Efficacy of Preservative Treatment and Physical Barriers in Preventing Biodeterioration of Rubber Wood under Estuarine Environment

A. Sreeja¹ and Leela Edwin*

Central Institute of Fisheries Technology, P.O. Matsyapuri, Cochin - 682 029, India

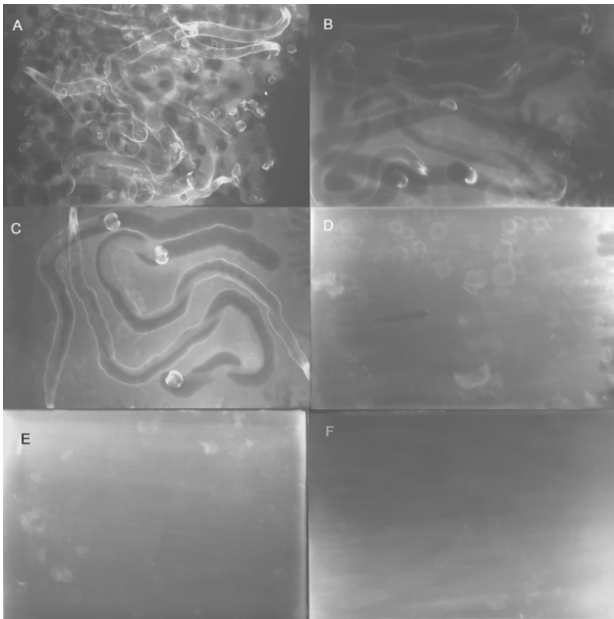
X-ray radiographs revealed the presence of long tunnel like burrows deep into the wood (Fig.1). These tunnels were lined with calcareous shell

Fig 1. X-ray radiograph of estuarine exposed rubber wood samples for 18 months showing attack by *Teredo* spp. and *Sphaeroma* spp. A: untreated rubber wood, B: Marine plywood, C: CCA treated to 16 kg m⁻³, D: CCA treated to 29 kg m⁻³, E: CCA treated to 42 kg m⁻³, F: Dual treated

characteristic to *Teredo* spp. that appeared darker than the surrounding wood. After an exposure period of six months, tunnel like burrows with an average diameter of 9 mm was observed on

untreated and marine plywood panels. Three such long burrows of length 122, 86 and 70 mm were observed in the untreated panels while two such burrows of length 61 mm and 200 mm were observed in marine plywood. Untreated panels retrieved after 18 months were completely infested with *Teredo* spp. making it impossible to measure the area destroyed using X-ray radiograph. After twelve months, X-ray radiographs of panels of 16 kg m⁻³ CCA retention revealed two burrows of length 47 mm and 26 mm with an average diameter of 4 mm although no signs of borer attack was shown externally. CCA 29 kg m⁻³, CCA 42 kg m⁻³, dual treated panels, FRP and paint coated panels were without any internal tunnels.
