Impact of post monsoon rainfall and soil moisture conservation strategies to sustain Coconut productivity

ICAR-Central Plantation Crops Research Institute, Kasaragod 671 124, Kerala, India

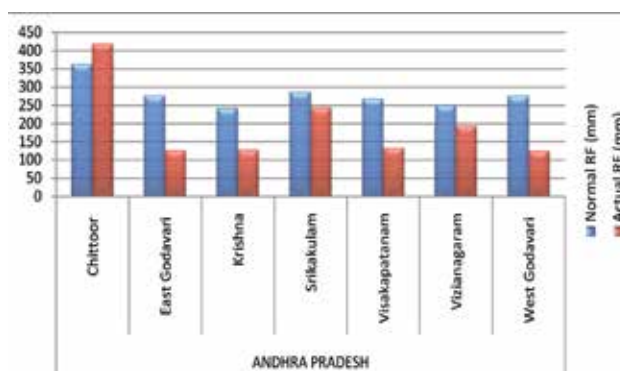
Fig.4

Rainfall received during the post monsoon season of major coconut growing districts of Andhra Pradesh revealed that except Chittoor and Srikakulam, other districts of Andhara Pradesh, recorded less than normal rainfall. (Table 4 and Fig. 4). The worst affected districts are East Godavari and West Godavari (-55 %).

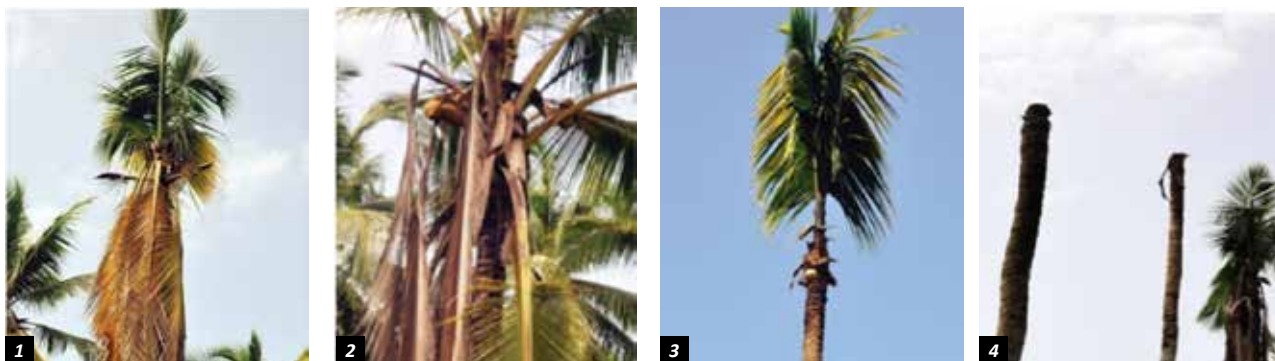
(Fig. 5) Effect of moisture stress on coconut palm

1. Yellowing and drooping of lower leaves
2. Yellowing and drooping of lower leaves Petiole breakage, a typical symptom of moisture deficit stress
3. Drought affected palm, with only central whorl of leaves
4. De-topping and death of drought affected palm

be below optimum under inadequate moisture conditions. Moisture stress and poor absorption of nutrients leads to yellowing of lower leaves, drying of leaves and petiole breakage. Breakage of leaf petiole is the typical symptom of the palms affected by drought. The dried leaves then fall off, leaving only a few green leaves on the crown. Subsequently these top leaves also fall off and even a low velocity wind results in to de-topping and death of the palms (Fig. 5)

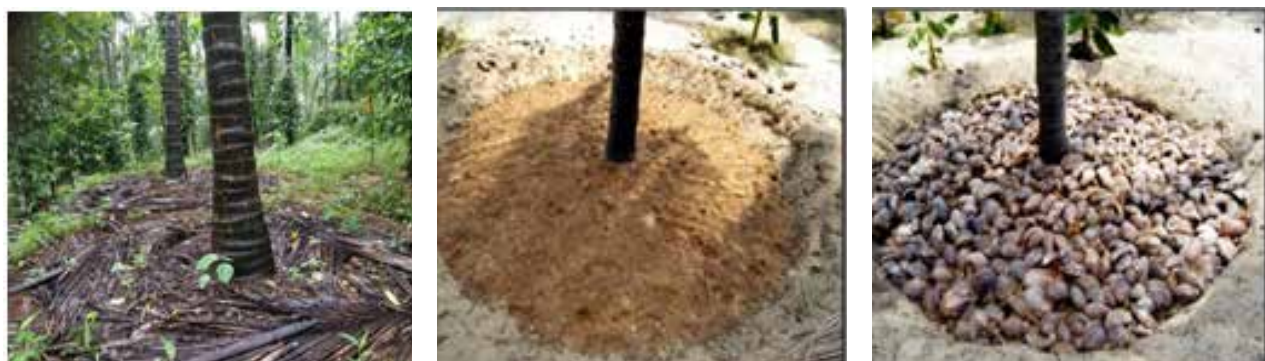
Dried coconut leaf mulch

Coconut husk mulch

(Fig. 6) Organic mulching materials

Mulching is the simplest and most effective moisture conservation practice for sustainable coconut production. In order to conserve soil moisture in coconut plantations, mulching with various types of organic materials viz., coconut leaves, husk and coir pith can be practiced (Fig. 6). Mulching not only helps in reducing soil temperature and evaporation of moisture from soil surface, it also creates an ambient condition for proper root growth and proliferation of soil flora and fauna. The timing of mulching is crucial for effectively conserving soil moisture. Mulching the area around the base of the palm (1.8 - 2.0 m radius) before the end of monsoon (and before the top soil dries up) will help retain soil

For mulching, coconut leaves should be cut into two or three pieces and arranged in two to three layers in the coconut basins. About 15 to 25 fallen coconut leaves would be required to cover 1.8 m radius of a coconut basin.

Coconut husk and coir pith can hold moisture to the tune of three to five times of their weight and hence are ideal for mulching the basins and promote soil moisture conservation. Besides conserving soil moisture, coconut husk is an important organic material and a good source of plant nutrients. On an average husk constitutes 45% of the weight of nut and on this basis, a nut weighing 1,000 g will have 450 g of husk with 20% moisture. Approximately 250 to 300 husks would be required for one coconut basin. Decomposition of the mulches after a period of time results in enrichment of soil organic matter pool. On dry weight basis, the average composition of husk is 0.23% N, 0.04% P, 0.78% K, 0.08% Ca and 0.05% Mg. For mulching one coconut basin with coir pith to 10 cm thickness, approximately 50 kg coir pith would be required. Due to its fibrous and loose nature, incorporation of coir pith considerably improves the physical properties and water holding capacity of soil and thereby increases the coconut productivity. Mulching of coconut basins can also be done with other organic wastes such as completely dried weeded material.

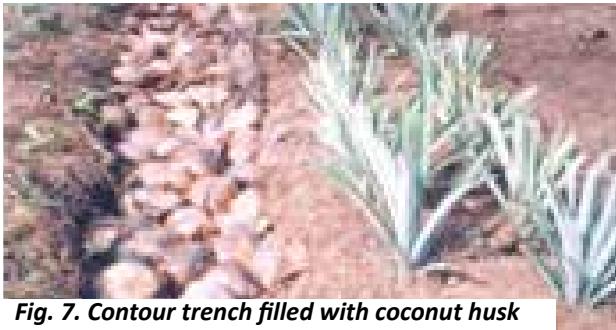
Fig. 7. Contour trench filled with coconut husk

This measure is to be taken up where the land slope is high (7-22%). Trenches of 50 cm width and 50 cm depth and of convenient length (preferably 4 m length) are to be made (across the slope) in between two rows of coconut palms. The trench should be dug in such a way that it would not come in line with the basin area and will trap the water flowing down the slope from the area in between the coconut basins. These trenches are to be filled with layers of coconut husk, with the bottom layers facing up (concave side up) and top layer facing down. A bund of 50 cm height and suitable width (50 cm) is to be made at the downstream of the trench using the excavated soil. To stabilize the bund, two rows of pineapple plants are to be planted on the bund at a spacing of 20 cm x 20 cm (Fig. 7). Pineapple plants in addition to stabilizing the bund, would also provide additional income to the farmer. The runoff water from the upstream, along with soil particles in the runoff water gets collected in the trenches. The coconut husk retains the moisture for a longer period and makes it available for plants during summer months. Adoption of this intervention in coconut plantations (in farmers holdings), was effective in soil

and water conservation, with 98% reduction in the soil loss (0.14 t/ha) as compared to control (10.52 t/ha) and recorded lesser water runoff (0.17%) as compared to control (5.6%). Similar results were obtained in terms of nutrient conservation, with minimum nutrient loss (1.28, 0.20 and 1.15 kg/ha/year N, P₂O₅, K₂O, respectively) as compared to control (105, 22 and 167 kg/ha/year N, P₂O₅, K₂O, respectively), with a per hectare yearly nutrient saving of 103.7 kg nitrogen, 21.8 kg phosphorus and 166.85 kg of potassium. A positive effect on coconut yield under rain fed conditions was also observed (over a four year period), with a 162 % increase in coconut yield (93 nuts/palm/year), over pretreatment yield (35 nuts/palm/year), as a result of these management practices.

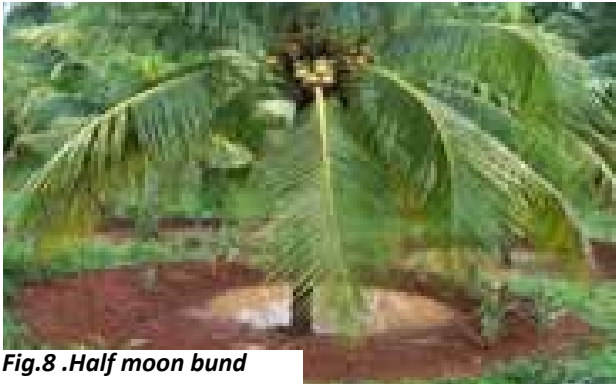
Fig.8 .Half moon bund

This is another effective method for conserving precarious natural resources, viz. soil and water and has been successfully demonstrated in coconut plantations. This measure is to be taken up where there is mild slope. Here a flat basin with a slight inward slope in the upstream is made by excavating soil from the upstream side and shifting the excavated soil to the downstream side. A bund of 50 cm height and 50 cm width is made at the downstream side of the coconut palm using the excavated soil. Two rows of pineapple plants are to be planted on the bund, with a spacing of 20 cm row to row and 20 cm plant to plant (Fig. 8). The bund prevents runoff and water gets collected within the basin and percolates down. Roots of pineapple act as a reinforcement to stabilize and protect the bund, in addition to giving additional income to the farmer through fruit yield. About 94% reduction in soil loss (annually to the tune of

0.59 t/ha as against 10.52 t/ha in control) was recorded in farmers gardens, due to adoption of this simple technology. Similarly, less nutrient loss was also observed (3.30, 0.83 and 4.18 kg/ha/year N, P₂O₅, K₂O, respectively) as compared to control (105, 22 and 167 kg/ha/year N, P₂O₅, K₂O, respectively). Higher soil moisture content was observed even during post monsoon period, up to four months after cessation of rains, in comparison to control wherein the coconut palms reached almost close to permanent wilting point within two months after cessation of rains. Along with the reduction in runoff, soil erosion, nutrient loss, 63% increase in yield (70 nuts/palm/year) over pre treatment yield of 43 nuts/palm/year was also recorded (Mathew *et al.*, 2018).

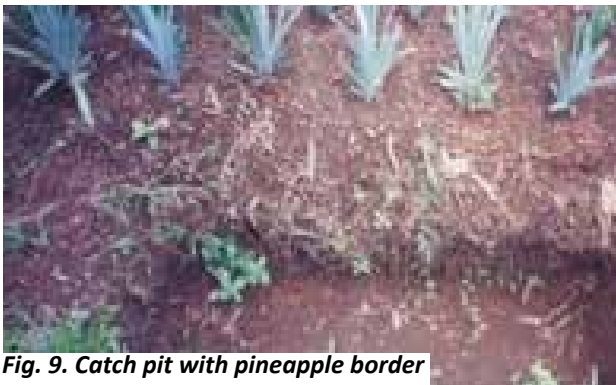
Fig. 9. Catch pit with pineapple border

Catch pit technology is very effective in conserving soil and water resources and can be constructed in all slopes. By adopting this technique, the soil loss was 0.69 t/ha/year and the nutrient loss was 2.71, 0.56 and 3.87 kg/ha/year, N, P₂O₅ and K₂O, respectively. Though there are no standard dimensions for catch pits, for convenience catch pits of 1.5 m length x 0.5 m width x 0.5 m depth can be adopted. A bund is to be made downstream of the catch pit using the excavated soil and strengthened by planting pineapple plants (Fig. 9). This pit may or may not be filled with coconut husk. If it is without husk, periodic measurement of the depth of the pit indicates the amount of soil collected inside the pit, a direct measurement of soil erosion. Remarkable impact of catch pit on coconut palm yield was observed at ICAR-CPCRI, with a 96% increase (49 nuts/palm/year) over the pre treatment yield (25 nuts/palm/year).

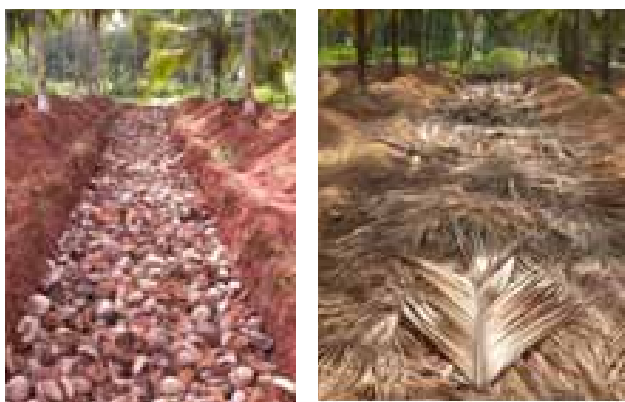
Fig.10 . Coconut husk or leaf burrial in interspace

Husk or leaf burial in interspaces can be undertaken in any coconut plantation, for moisture conservation. Trenches of 120 cm width x 60 cm depth and convenient length can be made in between two rows of coconut palms. These trenches are then filled with coconut husk and/or coconut leaves (Fig. 10). Coconut husks need to be filled in layers with the bottom layers facing up and top layer facing down. The top portion of the trenches are filled with coconut leaves and finally covered with soil.
