SCHEMES IMPLEMENTED BY THE DEPARTMENT OF SOIL SURVEY & SOIL CONSERVATION UNDER THE KUTTANAD PACKAGE

REPORT ON THE EVALUATION

ICAR - CENTRAL PLANTATION CROPS RESEARCH INSTITUTE
P.O. Kudlu, Kasaragod – 671 124, Kerala

Evaluation of soil and water conservation projects under Kuttanad package

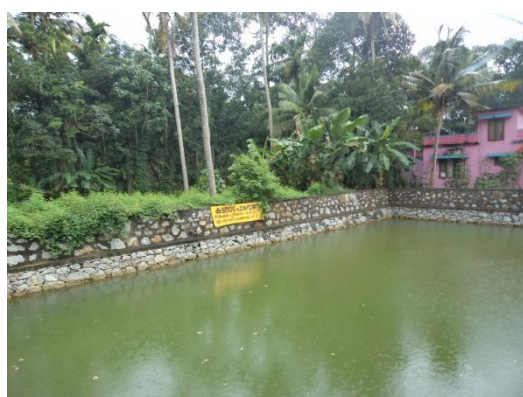
Thavalamkulam Pond

An existing pond was renovated to a size of 27m L X 24m B X 3m depth. A safe outlet provided to remove excess water, if any.

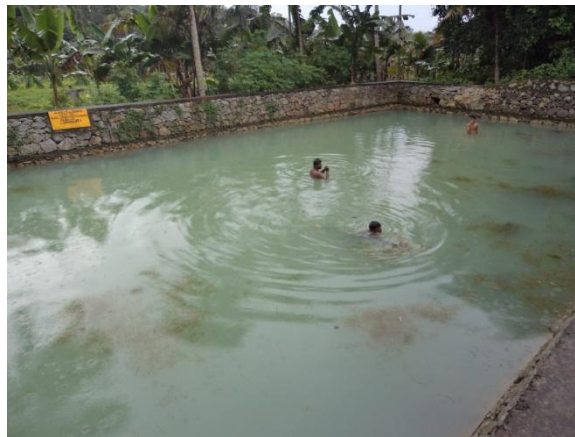
Perumbalakulam

Renovation of an existing pond in a similar manner as that of Thavalamkulam Pond. Dimension of the pond is 22m Length X 16m Width X 2.5m Depth. Provision is made to take the water to the nearby fields for irrigation. However, no irrigation is done using the pond water. It is being utilized as a recreational facility, swimming by the local people.

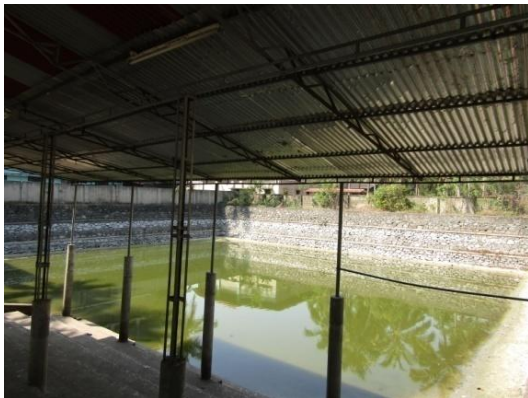
Pond at Kakazham Muhamudeen Juma Masjid

An existing pond was renovated to the size of 30m L X 30m B X 4m depth with an expenditure of Rs.17.1 lakhs. The existing pond was de-silted, shaped and the capacity was enhanced by increasing the depth to another 2m before constructing the granite side walls. Standard construction procedure was adopted with DR foundation, two RCC belts in between and CC at the top. The pond has been utilised mainly by the local people and people coming to the mosque for worship. A nearby school, Al Ameen School, also depend on this pond for its water requirement. Irrigation also was provided to few coconuts and banana nearby, according the convenor, Sri. M Shafeeq. Prior to the construction the mosque used to spent approximately Rs.22,000/- every year to clean the pond.

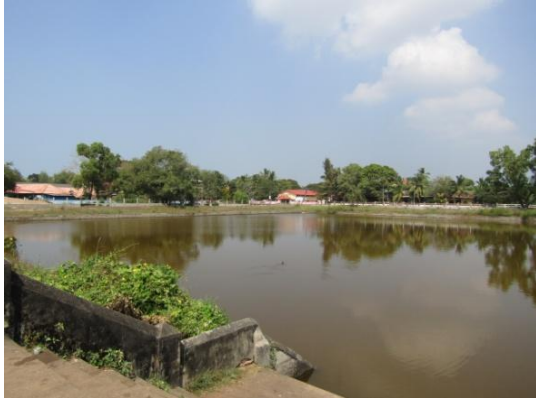
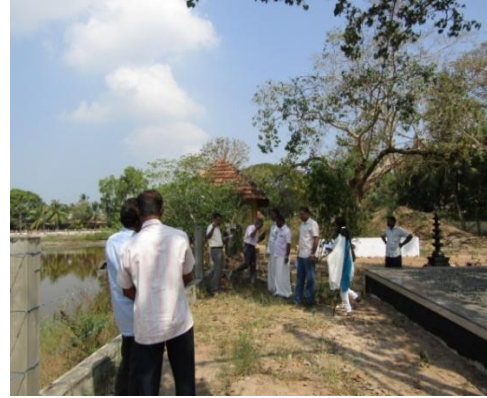
Thanakulam

coir geotextiles. However, no seeding, sowing seeds of grass, was done along with it which is nearly mandatory to stabilise the slope for a long duration.

The team could observe using coir geotextiles to stabilise an embankment at one location. Slopes at the banks of 'Thanakulam' was protected using coir geotextiles. Coir geotextiles is an excellent material to protect/ stabilise slopes for a small duration, one

season effectively. Newly formed slopes, embankments/ banks of drains with steep slope that needs immediate protection from erosion are usually treated with coir geotextiles. However, being a bio degradable material it can retain its strength only for a short duration and decomposes within one or two season. Therefore it is mandatory to ensure that sufficient vegetation would come up and protect the slope by this time. Ideally seeds of closely growing grass needs to be sown along with laying the coir geotextiles. The geotextile would provide immediate protection to the slope during first rainy season and starts to deteriorate after that. By this time the grass would grow and provides permanent protection to the slope. The decomposed coir geotextile would be a bio fertilizer to the grass. However, sowing grass seeds which is an integral part of this intervention was not anticipated in the planning stage.

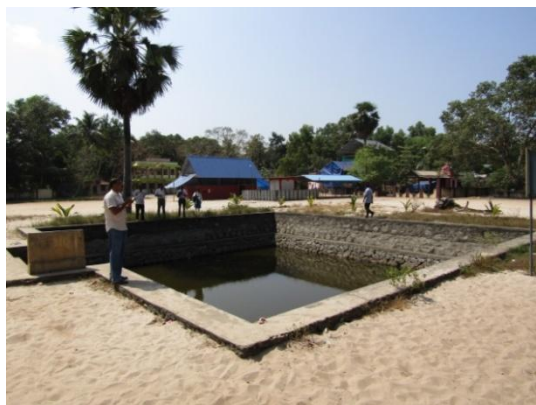
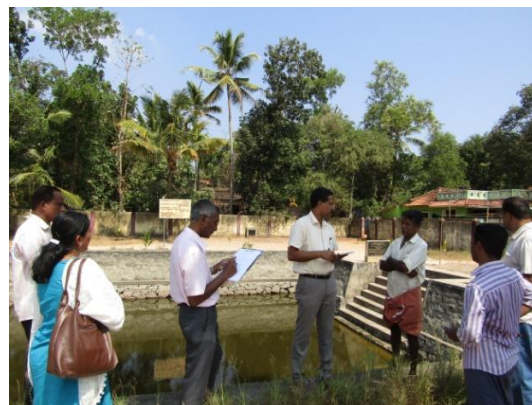
Thiruvilakku kshetrakulam belongs to SNDP Branch No. 3495 was renovated at a cost of Rs.10lakhs. The pond was deepened to an extra 1.5m prior to constructing the retaining wall. The capacity of the pond after renovation was 15m X 14m X 4m. According to Sri. Balakrishnan, a beneficiary the team met, the temple authorities used to clean the pond every year prior to the renovation which was labour intensive. After renovation the cleaning was done only by using pump since the silt accumulated has reduced considerably.

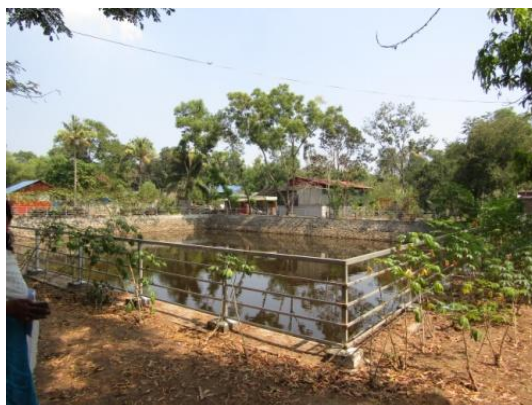
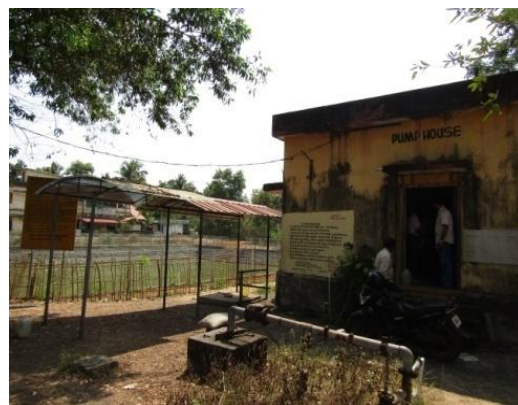
Komalapuram Plasukulam

The pond was a well protected earthen dug out pond belongs to the local Panchayath. The panchayath used to clean the pond every year. The region faces acute shortage of potable water. An RO plant, a water purification plant using Reverse Osmosis technique, functions near to the pond. The plant draws water from a tube well adjacent to the pond. Effluent of the RO plant is discharged to the pond. The pond was renovated by constructing retaining walls and the present size of the pond is 37m L X 34m B X 3.5 m depth. The pond is being used to rear fish, irrigate vegetables in 50cents of land nearby and for rituals of the nearby temples according to Sri. Vasudevan B, convenor and Sri. Mohan Das, a beneficiary.

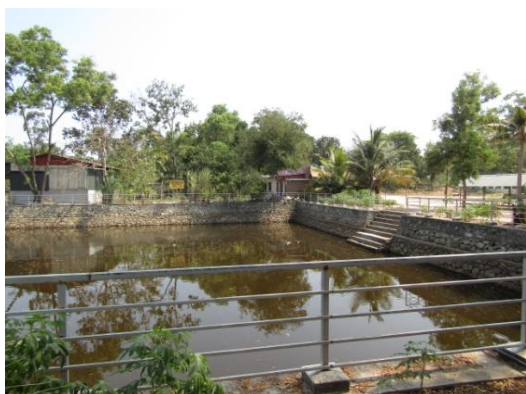
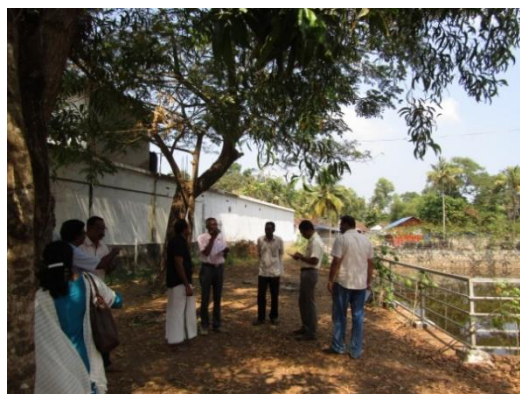
Ambanakulangara Pond

The pond was mainly used by people coming to the nearby temple for bathing. Apart from that it was used to rear fish and few local people for daily bathing. The pond was in a bad shape and was filled to a great extent with silt. During summer the pond used to get dried. People used to make a small pond within the pond at the centre by digging and the dug out soil was filled at the sides within the pond to reduce cost. The renovation was carried out by de-silting and enhancing the depth to two more metres and protecting the sides by constructing retaining walls. The rail above the retaining walls was provided by the temple authorities. Dimension after renovation was 42m L X 38.5m W X 4m D.

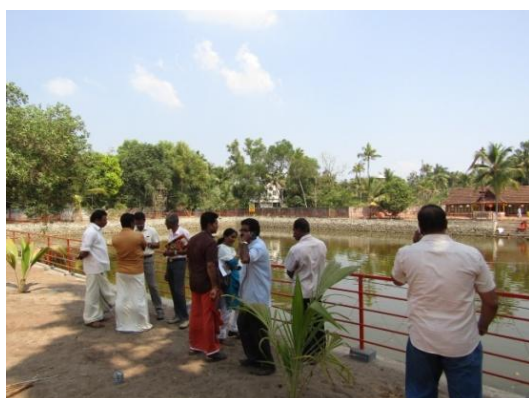
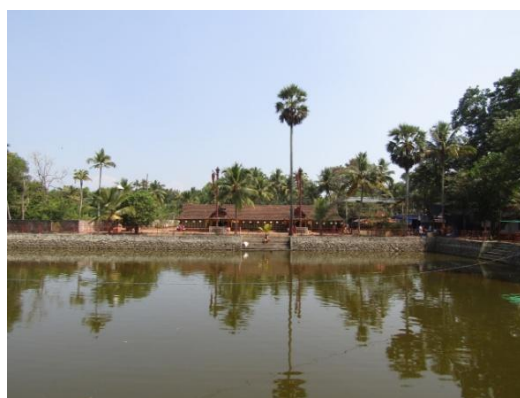
Thrikovil Temple Pond

The pond belongs to Mannancheri Ayyappa Seva Sangam Shakha No.2357. The pond was 72m L X 47m W X 3.5m D in size. Sri. Prasanth and Sri. Rajendran two beneficiaries the team met informed that the temple used to spend nearly two lakhs rupees to clean the pond every year. Construction of the retaining walls was similar to any other pond with granite stones having one belt and CC at top. Depth was enhanced to an additional 1.5m prior to the construction of the retaining wall. Very good construction. Additional protection by providing railings all around the pond was made by the temple authorities.

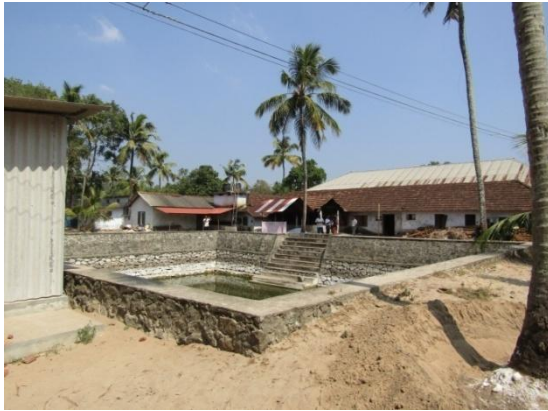
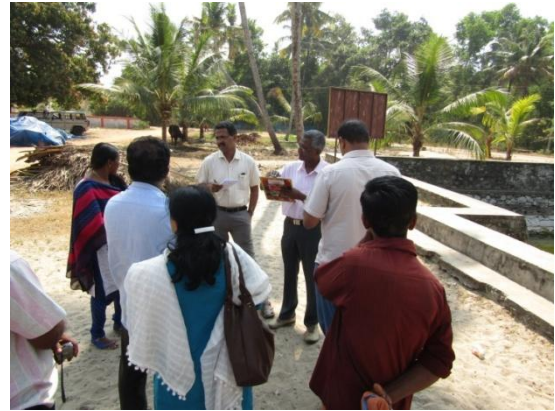
Kavunkal Khsetrakulam

The pond has a dimension of 20m L X 19mW X 4m D. 1.5m additional depth was created by excavation to assure water during summer. Fifty people utilise the pond daily apart from its utilization for temple rituals. According to Mrs. Minimol, Member,

Mannancheri Grama Panchyath, the pond was a pretty good intervention that helped the local people. Children after playing in the evening used to take bath here which for them is a recreation also.

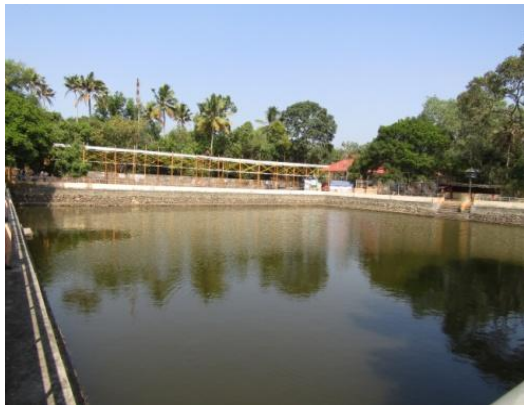
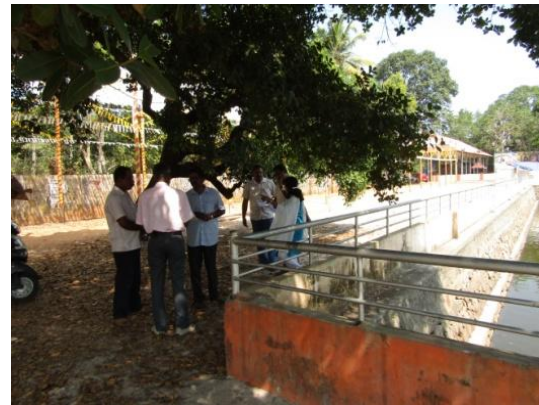
Valiyakalavoor Pond

The pond belongs to Valiyakalavoor Sri Krishna temple. This was having 50m L X 47m W X 3m D dimension after renovation. It is used mainly for temple rituals. Few local people utilise the same for bathing also.

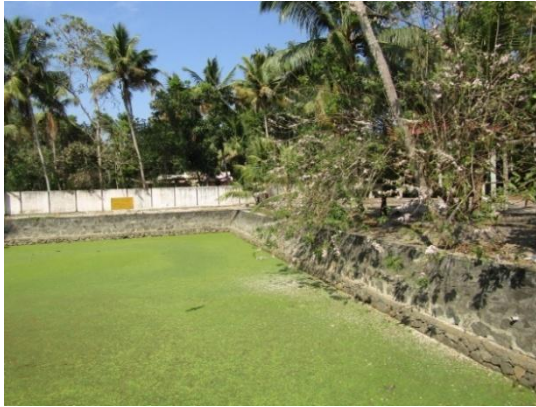
Mararikulam Temple Pond

Another renovated pond having a dimension of 31.35m L X 21.35m W x 3m D. Mainly used for ritual purpose.

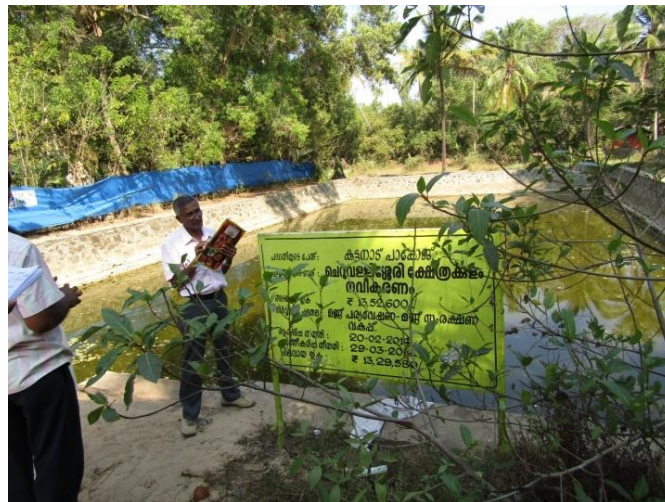
Cheruvallisseri Temple Pond

The pond was 34m L X 20m W X 3m D. Many people utilise the water for bathing. Earlier crops were irrigated by pumping from the pond.

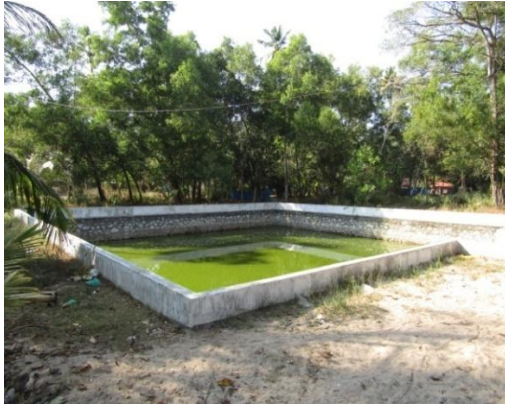
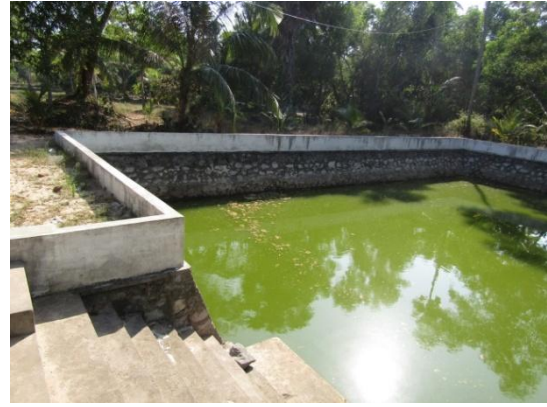
Poklasseri Sri Balabhadra Temple pond

The 22m L X 22m W X 2.5m D pond was renovated mainly for the temple purpose.

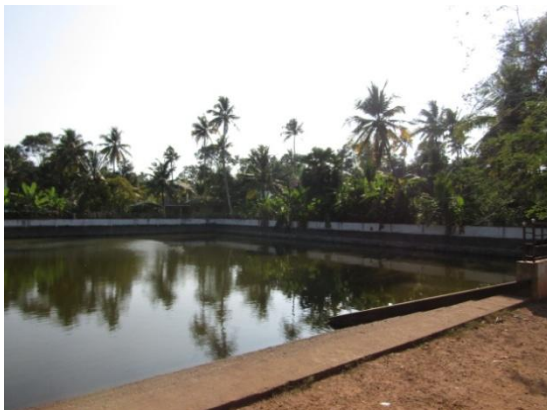
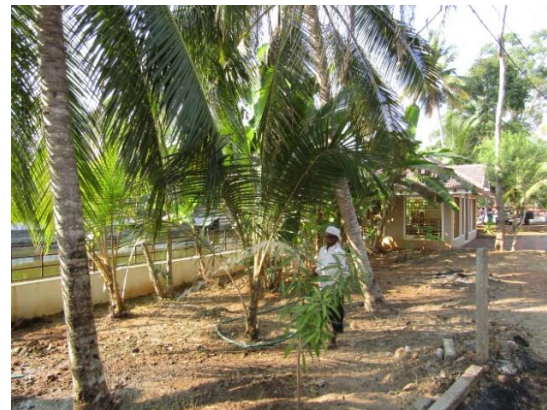
Velorvattom Temple Pond

A well constructed and meticulously managed pond of 56m L X 40m W X 3m D size belongs to the Velorvattom Temple. Three sides of the pond was protected by constructing retaining walls. One side where a road was passing nearby was having a retaining wall and was protected by it even before the intervention. Parapet and railings for additional safety was provided by the temple. Steps were provided at three sides for easy access. Coconut and banana plants on bank of the pond were irrigated using the pond water.

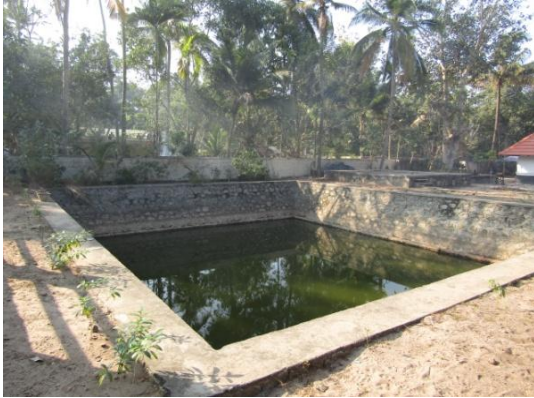
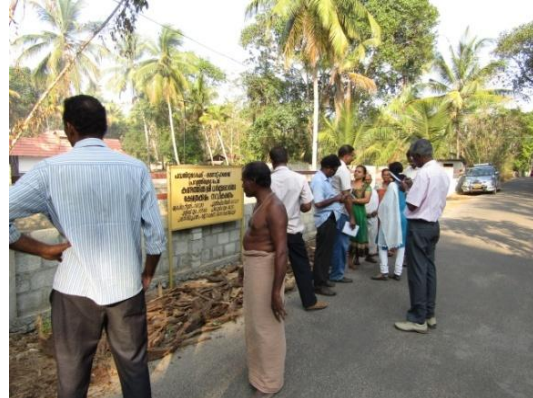
Kandathil Sri Dharma Sastha Temple

Size of the pond after renovation was 15m L X 15m W X 3.5m D. Depth of the pond was enhanced by 1.5m to ensure water availability during summer. Many nearby residents gathered at the site during the team visit. All were very much pleased about the

intervention. Mrs. Leela, an old lady and Sri. Vijayakumar and many neighbours gathered told that more than hundred people takes bath every day in the pond.

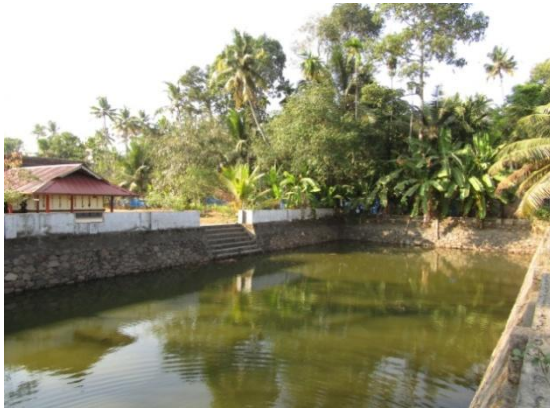
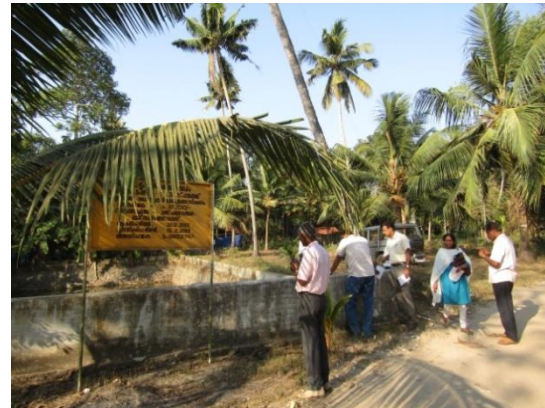
Olathala Trikayil Temple Pond

The pond was 32.1m L X 16.4m W X 2.5m D size. Parapet of the pond was constructed by the temple authorities. The water was shallow, only 50cm deep. One entrance was also provided.

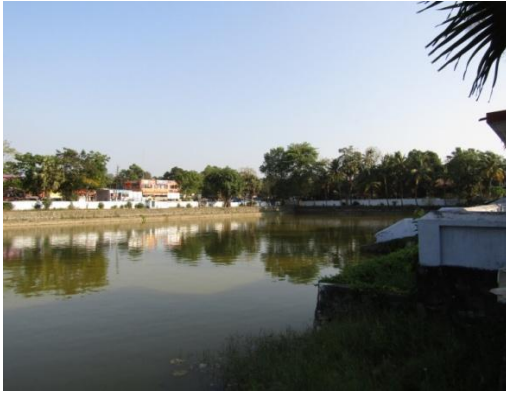
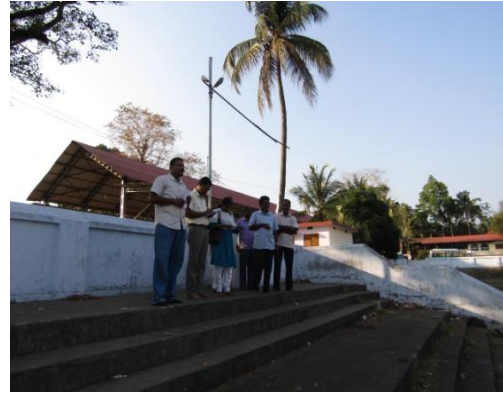
Thuravur Temple Pond

A pond belongs to Thuravoor Mahakshetra was renovated. A well managed pond before and after the intervention.

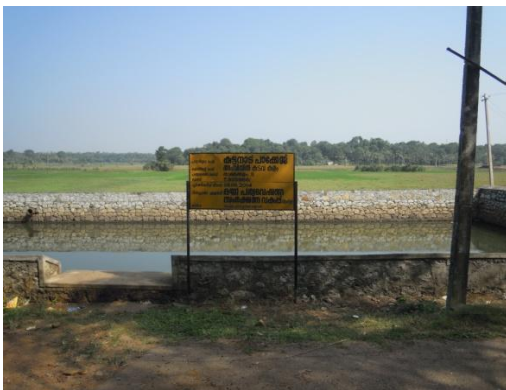
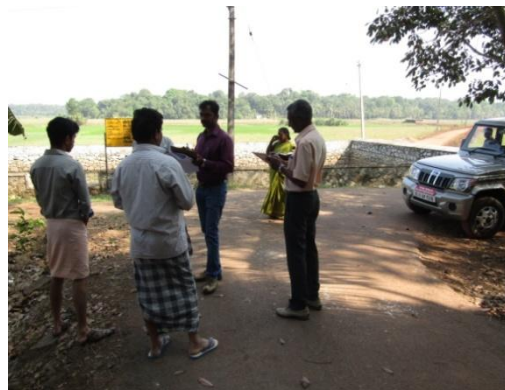
Ambiyil Kadavu Pond

An existing pond in a paddy field has been deepened to additional depth of 1m and renovated by constructing retaining wall at all sides. One outlet was provided for the extra water to drain off. The team could not find any benefit of the pond except that the water was used to irrigate a meagre quantity of vegetables and very few people takes bath in the pond. Farmers cultivate paddy adjacent to the pond. However, they take water from a nearby canal by pumping not using the pond.

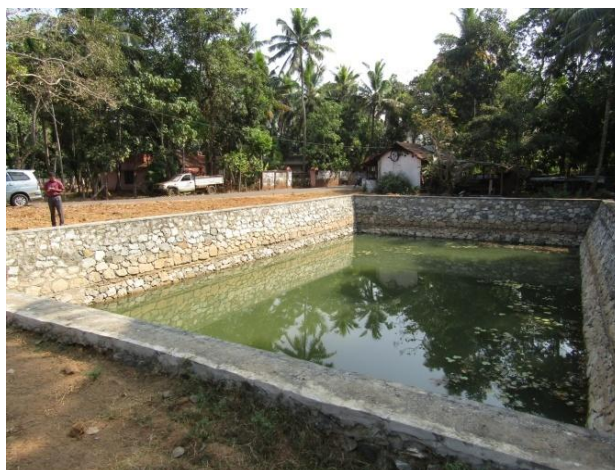
Poovathur Sastha kulam

An existing pond was renovated after enhancing the depth. The present size is 20m L X 18m W X 2.5m D. Bathing for the local population and temple ritual are the utilities of the intervention according to Sri. Prabhakaran Achari, Chairman and Sri. Prasad, a beneficiary.

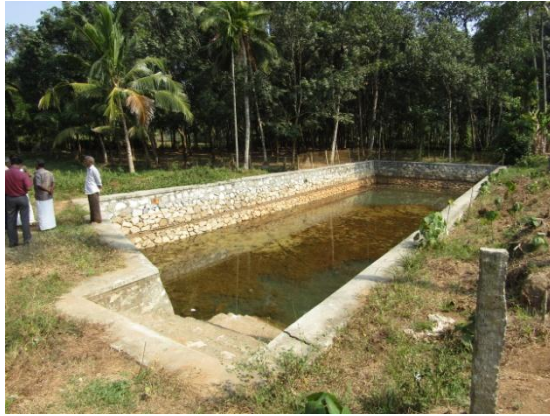
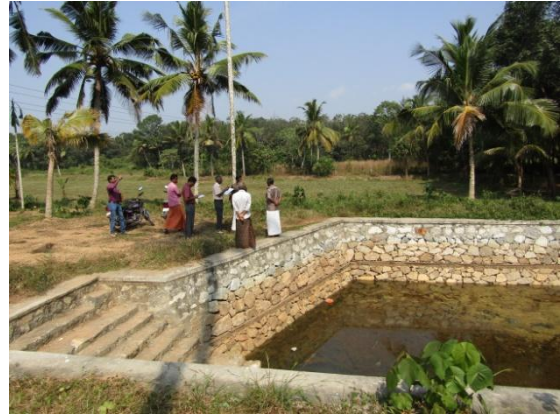
Thevarkulam

The pond belongs to the local Grama Panchayath. A nearby temple, Srikrishnaswamy Temple, Kannanamkuzhi, utilise the pond for its rituals. The pond is a well planned and executed piece of work. It was deepened and renovated by constructing retaining walls using granite to a size of 22m L X 13m W X 3m D. Sri. Srikumar, Sri. Mohanan Nair and Sri. Hariprasad, all were beneficiary farmers and members of the Srikrishnaswamy Temple committee, were having very high opinion about the intervention. The pond used to get dried previously. This became a perennial water source after deepening. Constructed in March 2016 the pond has already been utilised by five local farmers to irrigate banana and vegetables for one season in an area of approximately three acres. The water from the pond was pumped using diesel pump set for irrigation. The farmers got a profit of Rs.30,000/- from banana and Rs.25,000/- from vegetable cultivation from area of 1.5 acres of leased land utilising the pond water for irrigation. It is proposed to cultivate paddy and vegetables using the pond water for irrigation in another five acres of nearby land utilising the labour available under MNREGS. Another farmer has started cultivating vegetables in his 50cents of land using the pond water. When utilised fully the pond would cater the irrigation water demand of five farmers having three acres of land for cultivation, 50 people belonging to MNREGS cultivating five acres of land and another farmer to cultivate his 50cents of land. A very good intervention.

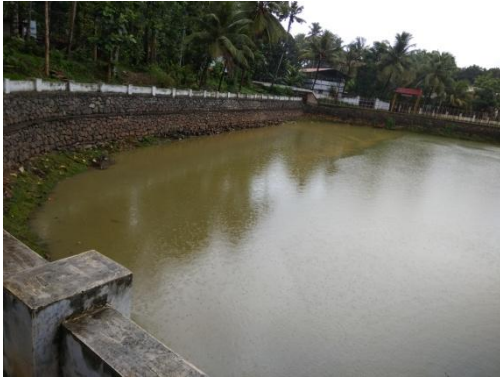
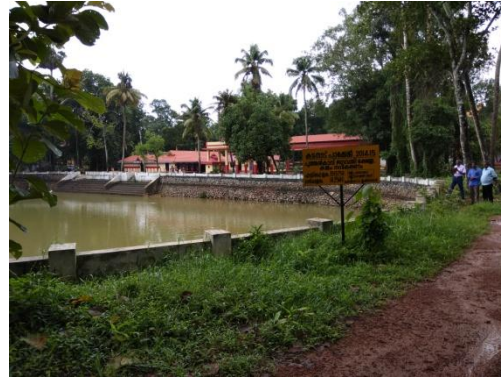
Renovation of Puthenkavu Bhagavathi Temple pond

An existing pond belongs to Puthenkavu Bhagavathi Temple was renovated by constructing retaining walls at three sides using granite stones. A granite retaining wall was already there in the fourth side of the pond, constructed by PWD to protect an adjacent road. The existing pond was de-silted, and the capacity was enhanced by increasing the depth before constructing the granite side walls. Standard construction procedure was adopted with DR foundation, one RCC belt at a height of 1.5m and CC at the top. A parapet wall was also constructed for protection. Average depth of the pond was 3.5m after renovation. The existing shape of the pond, two sides straight and other two sides near

round, was not disturbed during renovation. The pond has been utilised mainly by the devotees of the temple.

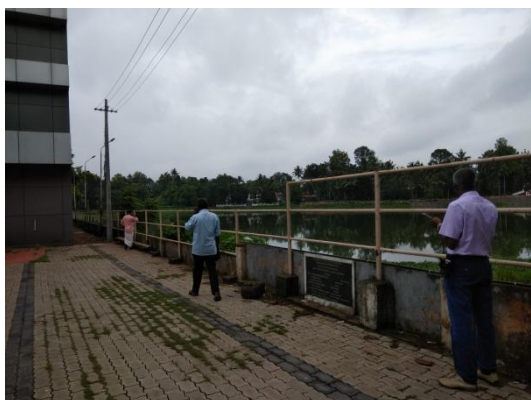
Pookkattuchira Pond

A massive pond of 3.2ha area was cleared of aquatic weeds and cleaned. The pond was then de-silted and deepened to another one metre making the total depth 2.5m. The pond is adjacent to the Changanassery Municipal park and hence it attracts tourists and local people visiting the park. Sri. Sebastian Mathew Manamel, Municipal Chairman whom the team contacted was very much impressed about the renovation work. As the Municipal Chairman he would utilise the pond for tourism/ recreation purposes. Fish culture also is there in the Municipality's pipe line This was done once in the pond. The team could see many people fishing in the pond as a recreation. The Botany dept. of S B college, a nearby college, is undertaking some studies based on the pond.

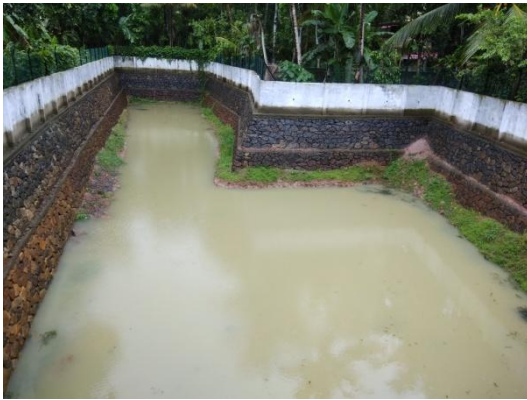
Thuruthi Irattakulam

An existing pond used to recharge an open well supplying water for ‘Irattakulam Drinking water project’ that supplies water to four wards of the local Grama Panchayath. The pond was cleaned and depth was enhanced to another one metre more and the sides were protected by constructing retaining walls. Belt, RCC, was provided at a height of 2.4m for additional strength. Total depth of the pond was 3.5m. The adjacent open well used to get dried after pumping for short period during summer prior to the renovation. After renovating the pond the well yields sufficient water for supply.

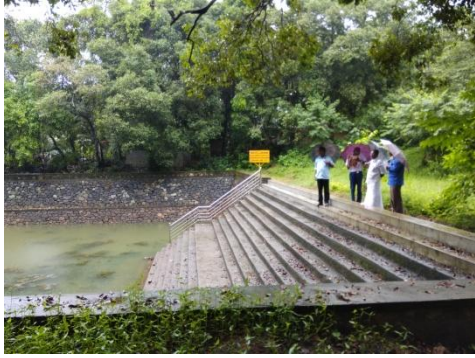
Easanathukavu Devi Temple Pond

A pond belongs to Easanathukavu Devi Temple was deepened and the sides were protected by constructing retaining walls using granite. One ramp and a step at one side were also constructed as part of the renovation. One belt, RCC, was provided at 1.8m height. Top of the retaining wall was protected by PCC and a parapet wall also was provided. The pond is of 40m length x 30m width x 5m deep. The pond is a perennial water source. The temple authorities informed that 2m standing water would be there in the pond even during peak summer. According to Sri. Radhakrishnan P., Secretary of the Temple nearly 75 people used to take bath in the pond. Apart from that 25 open wells near to the temple get recharged by the water stored in the pond, according to him.

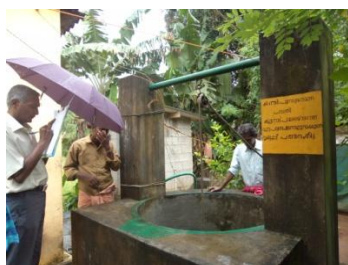
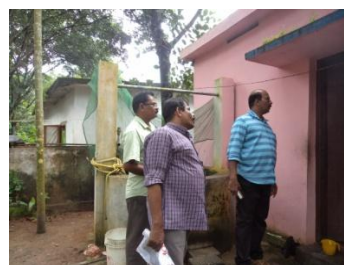
Open wells

Construction of open wells was another activity under the project. These open wells were constructed to provide drinking water to the beneficiary. All the wells were of similar type where concrete rings were provided to prevent the sides from collapsing. The team inspected three such newly constructed wells at the following locations in Pathanamthitta district. All the beneficiaries belonged to SC category. The wells were of great relief to the farmers. It is evident from the fact that the farmers got only a portion of their expenditure from the scheme. They themselves contributed for the balance amount required for the construction.

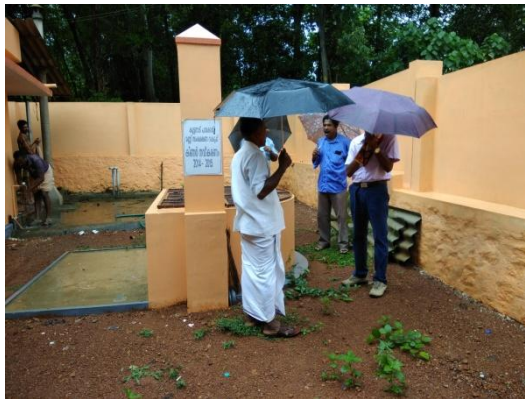
Open well renovated in the premises of Easanathukavu Devi Temple

An existing open well in the premises of Easanathukavu Devi Temple was deepened to 12m depth and parapet walls and two pillars constructed to provide rope and pulley to fetch water from the well. The temple authorities informed that there was no water shortage even during peak summer.

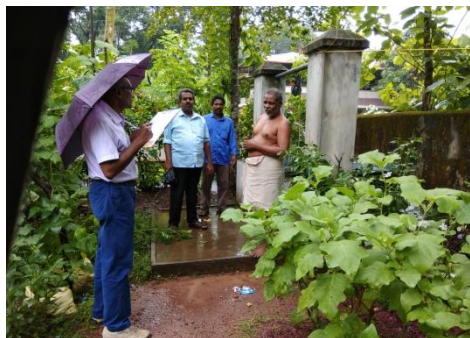
Open well of Sri. Mohanan V R

The open well of Sri. Mohanan V R, Ambazhaparambu, Payipadu was collapsed and was renovated under this scheme. The sides were strengthened by providing cement concrete rings with an amount of Rs.32,000/-. Depth of the pond after renovation was 23m. The water was used mainly for domestic consumption and to irrigate the kitchen garden having cow pea, brinjal, chilli etc.

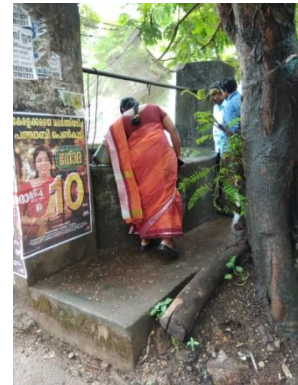
Open well near Pareppally church

An open well belongs to Changanassery Municipal Corporation near Pareppally church was renovated by after cleaning and de-silting. A parapet wall was constructed for additional safety since the well is just near to a tarred road. Sri. K M Antony (Babychan), a

nearby merchant, informed the team that the well is a perennial water source and during summer more than fifty people utilise the well. The well is approximately 10m deep.

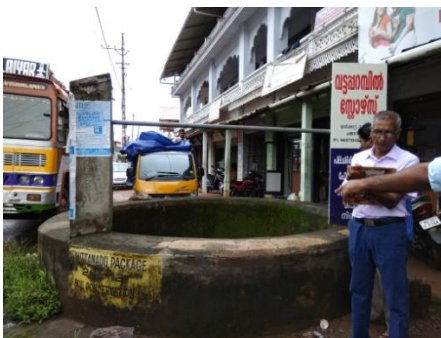
Open well in Vallapilly Market,
Changanassery

An open well in Vallapilly Market, Changanassery Municipal Corporation which was a perennial water source for many people was renovated. The well was cleaned, desilted and a parapet wall with provision for rope and pulley was constructed using the fund. Sri. James John, Vattaparambil stores and Joseph Antony, Maanjerikalam Agencies, two merchants adjacent to the well were very much impressed and convinced about the renovation work. According to them nearly 600 people, mainly labourers and other in the market, utilise the well daily for various purpose. The well is a perennial water source for the people in the market.

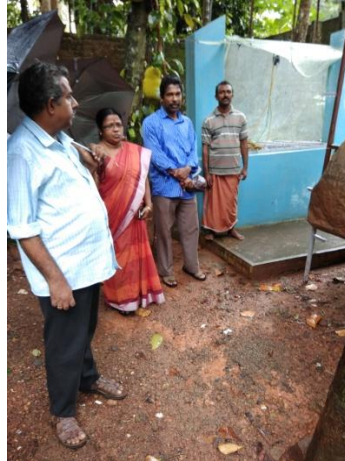
Open well of Sri. Thomas John

A new open well was constructed to provide drinking/ domestic water in the premises of Sri. Thomas John, Muyyappally, Thuruthi. The pond was dug and the sides were protected using cement concrete rings.

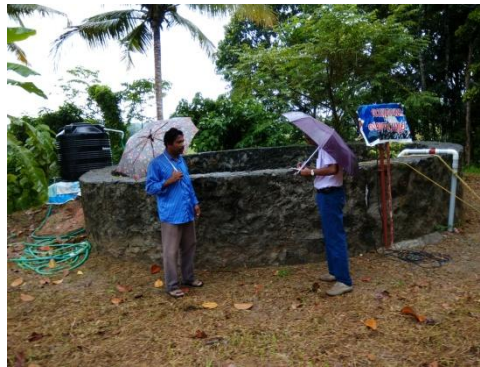
Open well at Sree Narayana Public School

Another new open well was constructed in the premises of Sree Narayana Public School at Chandanikadu, Panachikkad Grama Panchayath. An open well of 12m diameter and 12m depth was dug and retaining was constructed to protect its sides. The pond was used by the school to provide drinking water to the students. School authorities informed that the pond is utilised by the nearby public also for drinking water. A parapet wall was constructed for additional safety.

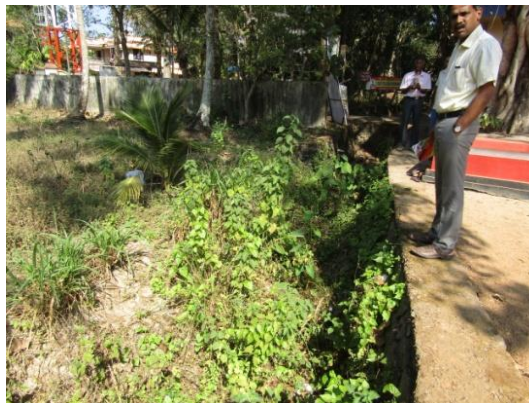
Vetiver Planting

The team visited three sites where vetiver planting was done to protect the stream banks of drains. In the first case vetiver planting was done at one side of a drain near Mararikulam Temple. Major portion of the drain, at both the sides, was protected from stream bank erosion by constructing retaining walls using granite by local Grama Panchayath. A small portion (10m) left unprotected was planted with vetiver, an excellent grass to protect the stream bank from erosion. However the team could see only a single plant. It was informed that local people uprooted the grass to take the root.

- Vetiver planting, an excellent intervention to protect stream bank from erosion, did not fully serve the purpose mainly due to lack of proper aftercare and management. This applies to the interventions on distribution of tissue-culture banana and medicinal plants as well. Hence, whenever this kind of intervention is implemented sufficient care should be taken to create awareness among the local community about the relevance and importance of the scientific practice recommended and also to ensure institutional mechanism involving local community for the proper after care and management of the crops planted.

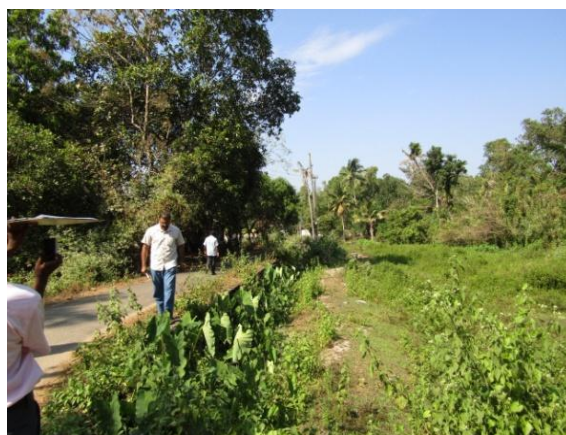
Vetiver Planting

The third site was also near to the temple where one side of a drain (120m) adjacent to a tarred road was protected by planting vetiver. However, the team could see only traces of the plant.

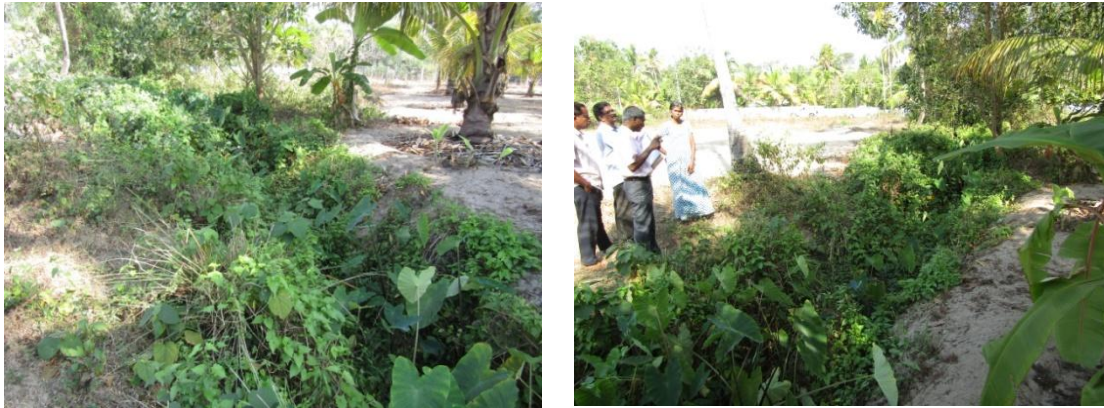
Vetiver Planting

Another site where the intervention was taken up was in Chethikadu Thodu. The stream banks to a distance of 600m was protected by planting vetiver at both the sides. The work was carried out in 2011-12 and the team could see only a few plants remaining at the time of visit.

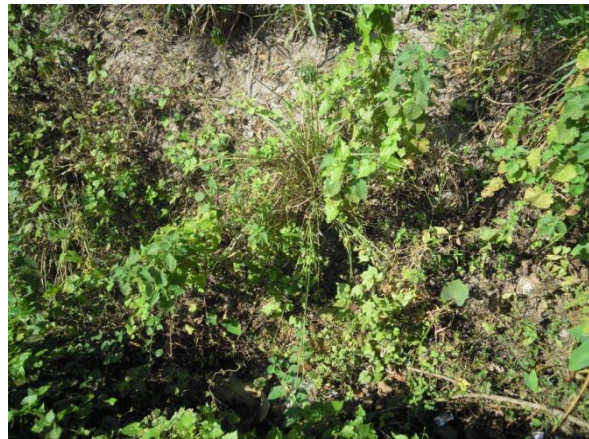
Vetiver Planting

The next site was near to Olathala Triakayil Temple where both the banks of a drain with a dead end was protected by planting vetiver. The team could not find any purpose for the intervention. They could not find any vetiver plant also still remaining.

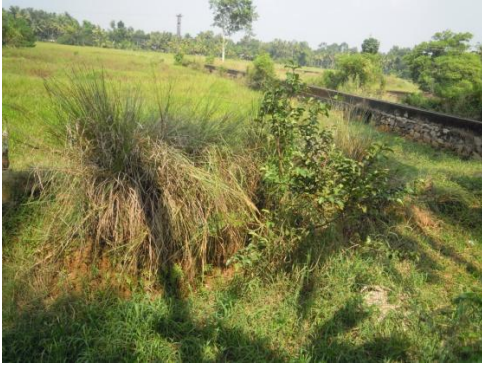
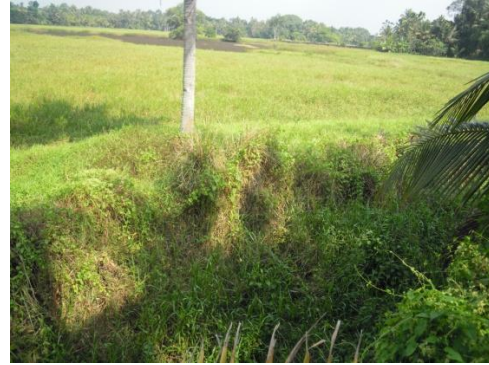
Vetiver planting to stabilise one bank of ‘Pachilavelil Thodu’

retaining walls. One side of the drain is in upper elevation (private holdings) and the other side paddy field. The bank at the paddy field side was not protected by retaining wall at some locations. These were protected by planting vetiver explained the convenor. It was planted two years back. The team could observe only patches of vetiver planting due to lush growth of weeds and other plants.

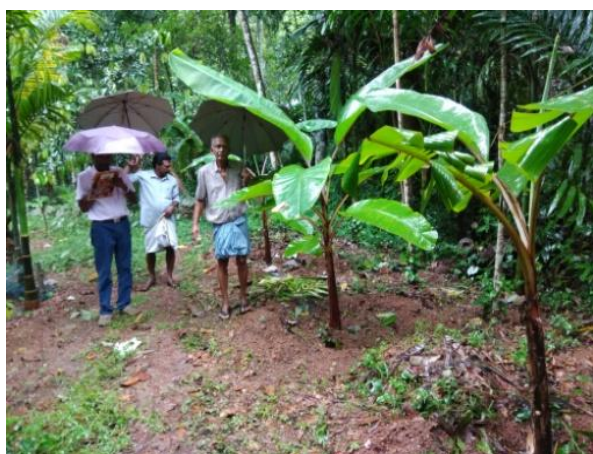
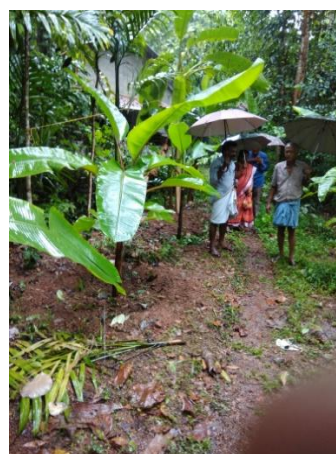
Tissue cultured banana in the farm of Sri. Varghese Kurian

Ten number of tissue cultured banana seedlings of two different varieties were supplied to the farmer. The farmer could get bunches having average weight of 8kg. However, the farmer planted suckers of only one variety next time, a red one. According to him the other variety was not tasty. The team could see only few plants of the red one during evaluation.

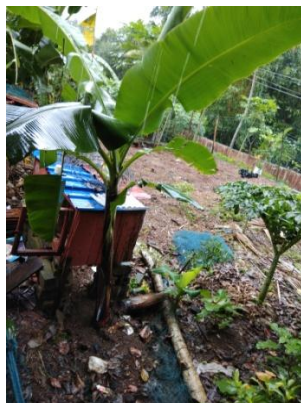
Tissue culture banana (Sucker)

Sapota, Mango, Nutmeg and tissue cultured banana were the items received by the farmer. Unlike the other farmers this farmer got four bunches from successive suckers for the variety Robusta. Other varieties received by the farmers got dried due to shortage of water.
