July 1979—Flash Flood in the Luni

A Case Study

**Central Arid Zone Research Institute,
JODHPUR-342003.**

CAZRI Technical Bulletin No. 6

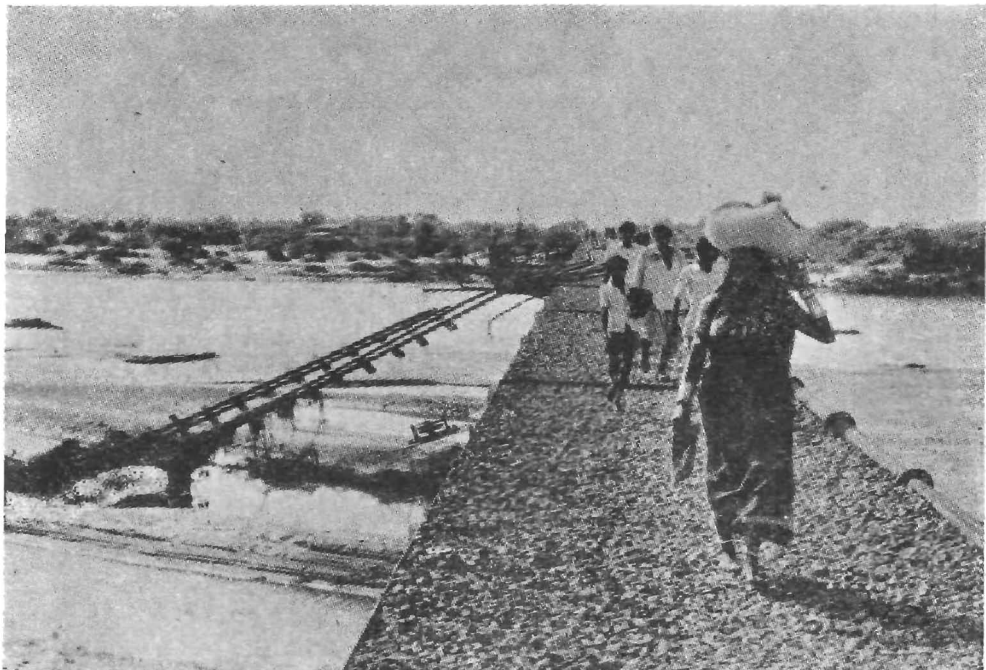
Scene over the railway bridge on the Luni. The track was washed away by the overflowing flood water.

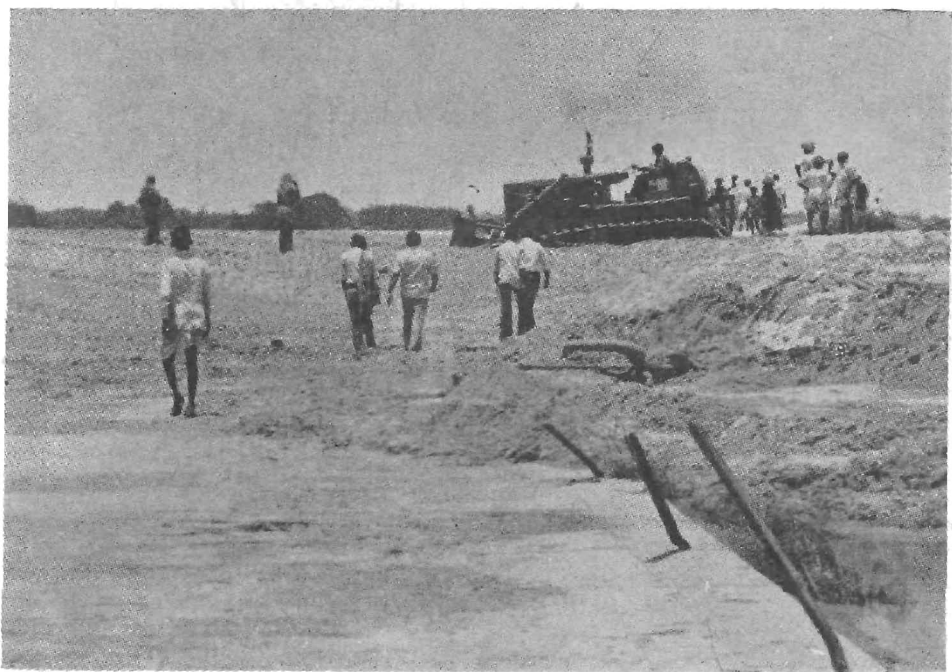
Scene at the Luni causeway on the Jodhpur-Pali highway.
The sand and gravel had piled up as high as 3 metres.

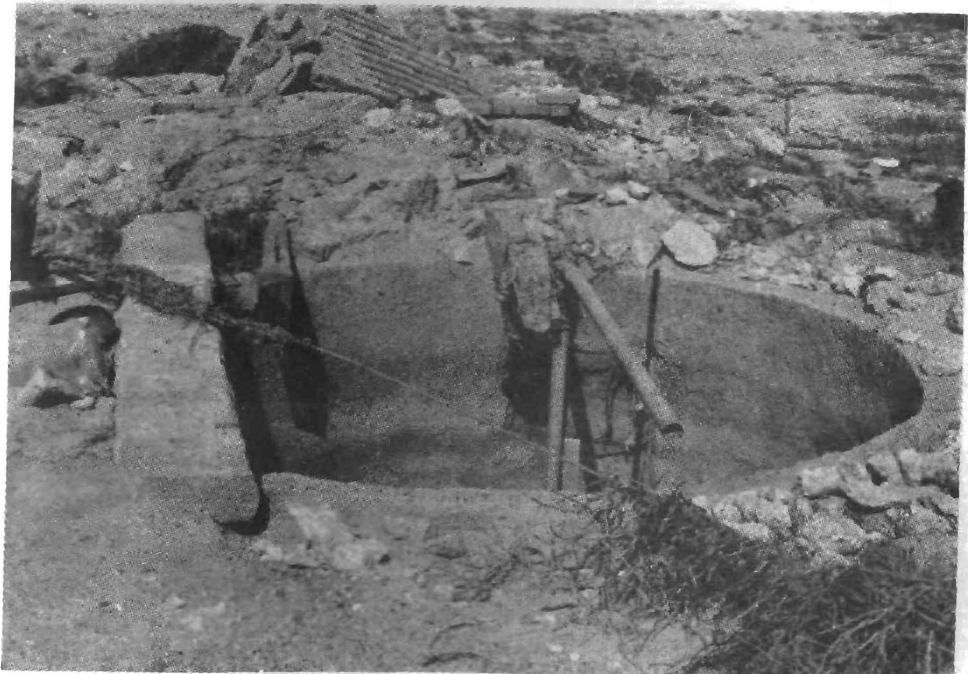
Collapsed structure of an irrigation well. Nearly two thousand five hundred wells together with the irrigation infrastructure are reported to have been seriously damaged.

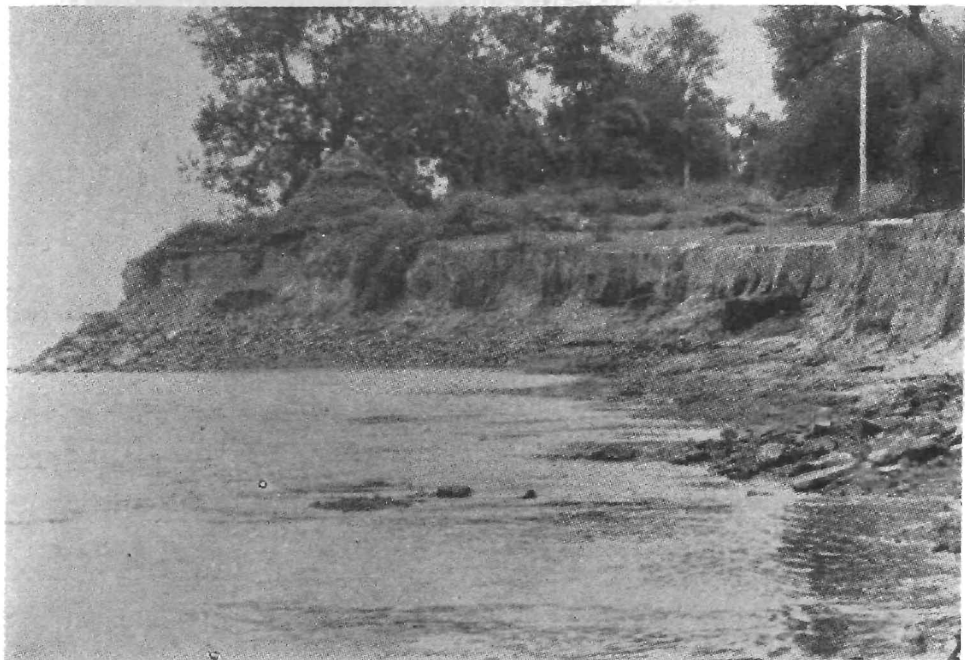
At this point the Luni has shifted about half a kilometre from its original course and annihilated the agricultural land (Village Silor)
