Prioritization, Planning & Development of a Micro-watershed in Drought Prone Area using Remote Sensing & GIS

CENTRAL RESEARCH INSTITUTE FOR DRYLAND AGRICULTURE
Santoshnagar, Hyderabad 500 059

First Printed : **December 2004**

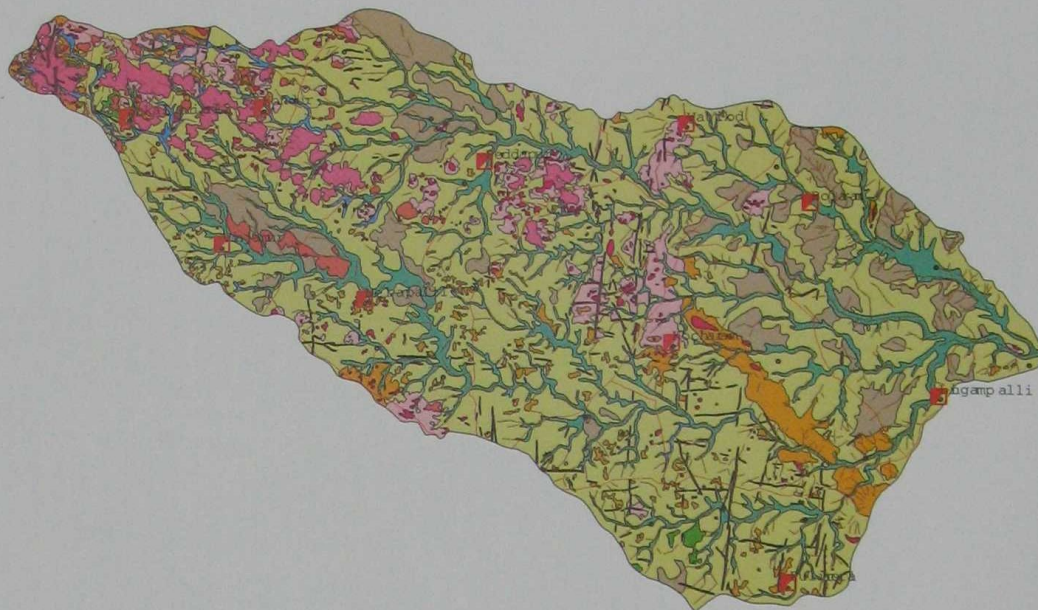
HYDROGEOMORPHOLOGY

Map Symbol	Geomorphic Unit/Landform	Description	Groundwater Prospects
	Valley Fill-Shallow (VFS)	Formed between high relief/uplands, and comprises of 0-5 mts fill material.	Generally Good. Yields 150-200 lpm. Better prospects supported by fractures/lineaments
	Buried Pediplain-Shallow Weathered (BPS-W)	Formed by the shallow overburden of transported/foreign material on prior pediplain, the thickness of the overburden generally varies between 0-10 mts.	Good to Moderate. Yields 100-150 lpm. Fracture zones are suitable for groundwater exploitation. The area generally comprises of black soil.
	Pediplain - Shallow Weathered (PPS)	Gently undulating plain; highly weathered with shallow thickness and large in areal extent. Formed by the coalescence of several pediments and inselbergs of Archean Granites. The depth of weathering generally ranges between 0-10 mts. The area is relatively upland when compared to PPM.	Good to Moderate. Yields 150-200 lpm. Better prospects along fractures / lineaments. The sites along this zone are good for groundWater exploitation.

Pediplain Shallow Weathered-Eroded (PPS-E)	Same as PPS, but it is relatively high upland and erosion is dominant.	Moderate to poor. Better prospects along the fractures / lineaments. Fracture zones passing through Pediplain's acts as conduits for ground-water movement.
	Pediplain-Moderately Weathered (PPM)	Gently undulating plain; highly weathered with moderate thickness and large in areal extent. Formed by the coalescence of several pediments of Archean Granites. The depth of weathering generally ranges between 10-20 mts.	Good to Very Good. Yields 200-300 lpm. Better prospects along the fractures/lineaments. The sites along this zone are good for ground water exploitation.
	Pediment (P)	Gently undulating granitic plain often dotted with rock outcrops, with or without thin veneer of soil cover.	Generally poor. Yields 80-100 lpm. Acts as runoff zone. Prospects limited to fracture/fissure zones.

Inselberg (I)	Isolated hill of massive type abruptly raising above surrounding plains. Formed by differential erosion.	Acts as runoff zone without any significant recharge or groundwater.
	Pediment-Inselberg Complex (PIC)	Isolated low relief/hillock surrounded by gently sloping, smooth, erosional bed rock with thin veneer of soil cover or detritus.	Poor. Yields 35-50 lpm. Prospects limited to fractures/lineaments and some times controlled by joints.
	Residual Hill (RH)	Formed due to differential erosion and weathering; occupies larger area when compared to inselberg. A more resistant rock formation stand as isolated hill.	Acts as runoff zone.
	Denudational Hill (DH)	Formed due to differential erosion and weathering; occupies larger area when compared to residual hill. A more resistant rock formation stand as isolated hill.	Acts as runoff zone.
	Dyke Ridge (DR)	A narrow linear resistant ridge formed by differential erosion.	Nil. Acts as barrier for groundwater movement.

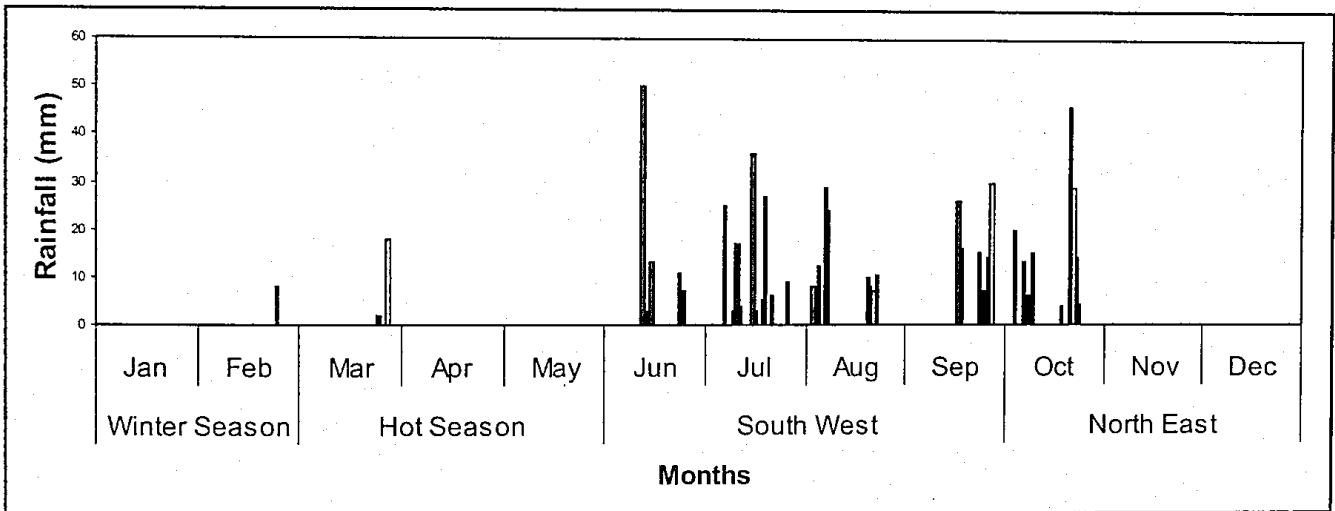
Fig. 4.2 Rainfall during 2003

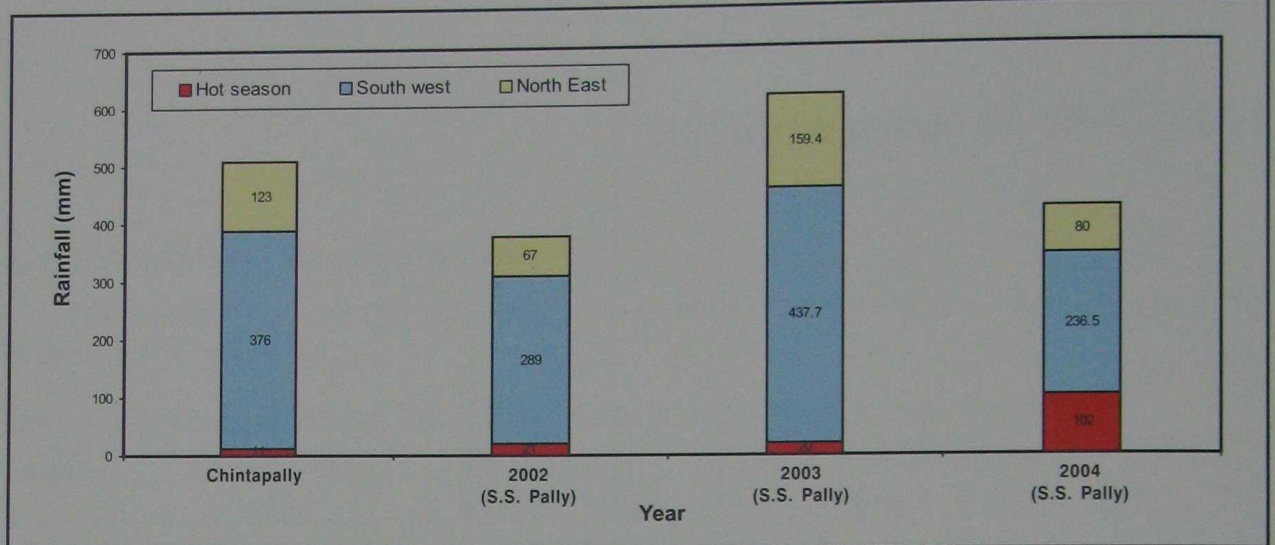
Fig. 4.4 Seasonal rainfall of S.S. Pally compared to average rainfall of Chintapally mandal

The average rainfall of 510 mm (from 1988-2001) was observed in Chintapally mandal and having high coefficient variation (43%) where as the highest average rainfall (837.7 mm) was observed in Thungaturthy mandal with coefficient of variation of 24%. Besides, the ground water status of Chintapally mandal falls under OE category and the meteorological drought frequency is very high (4.3%). Considering the facts as stated above and poor water resource availability, S.S. Pally village under Chintapally mandal was considered as priority area for development. The distribution of rainfall of S.S. Pally village for the 2002 to 2004 is presented in figs. 4.1 to 4.4. It is observed that there is a wide variation of rainfall and its distribution in the mandal and this calls for installation of rain gauge in each revenue village.

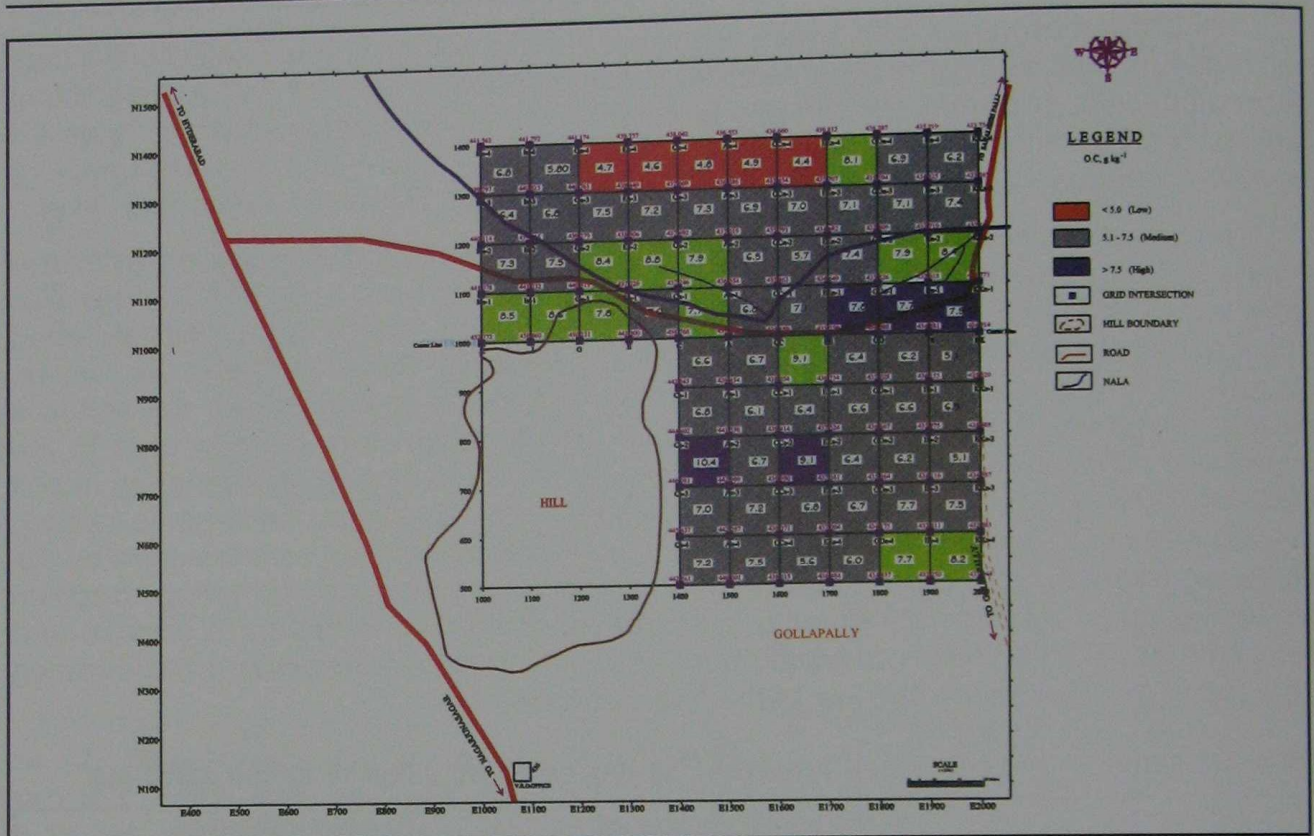
Fig. 4.5 : Soil organic carbon status in the S.S. Pally micro watershed

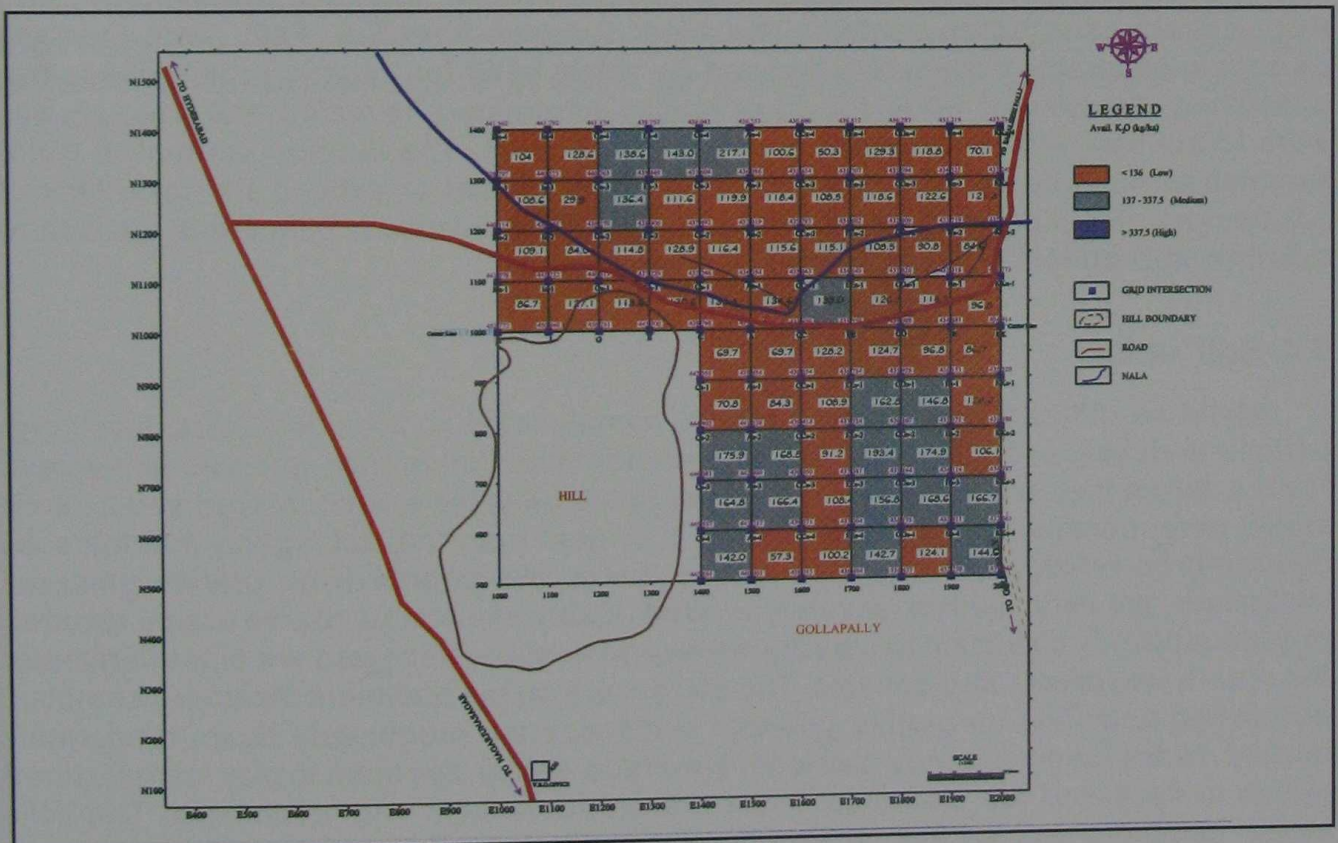
Fig. 4.8: Available K (as K_2O) in the S.S. Pally micro watershed

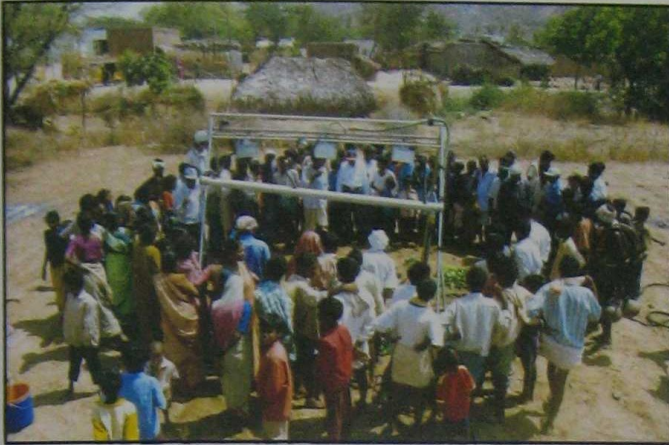
Fig. 5.10 Demonstration of rainfall simulator:
A crowd pulling action learning tool

Before preparing action plan a meeting was held in the village for finalizing the developmental works in watershed area and PRA was conducted. Demonstrations on the resource losses (runoff and soil loss) were done using twin plot portable simulator developed by Queensland Department of Primary Industries, Australia (ACIAR, 1997) (Figs. 5.10 & 5.11). In the twin plots of the simulator, farmers tried different options like along the slope cultivation, across the slope cultivation and mulching by gliricidia etc. The treatments were subjected to artificial rain through rainfall simulator. At the end of the experiment the villagers themselves measured the runoff volume, depth of wetting front and the colour of runoff water. They themselves concluded that across the slope cultivation and mulching are useful resource conservation measures. They showed interest to adopt cultivation across the slope as a conservation measures and grow gliricidia on the field bund for generating mulch material. Farmers showed interest for planting of trees like Mango, Teak, Sweet Orange and Custard apple etc. The action plan was prepared after thorough discussions with the villagers and conducting PRA (Fig. 5.12). The villagers gave their opinion by writing about the interventions in the meeting in presence of the project staff (Fig. 5.13). The final action plan showing all the interventions was prepared in a participatory mode (Fig. 5.9).

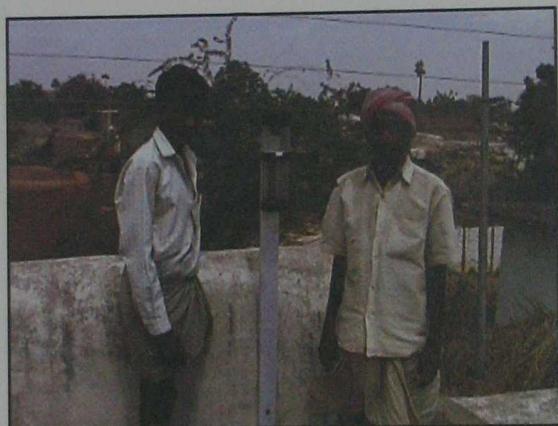
Fig. 5.14 Rain gauge (non-recording) on roof top of farmer's house

Two rain gauges were installed (Figs. 5.14 & 5.15) on the rooftop of a farmer's residence in order to create awareness among the farmers of the watershed village for measuring rainfall so that they can timely plan agriculture activities. A village youth was trained to measure the rainfall.

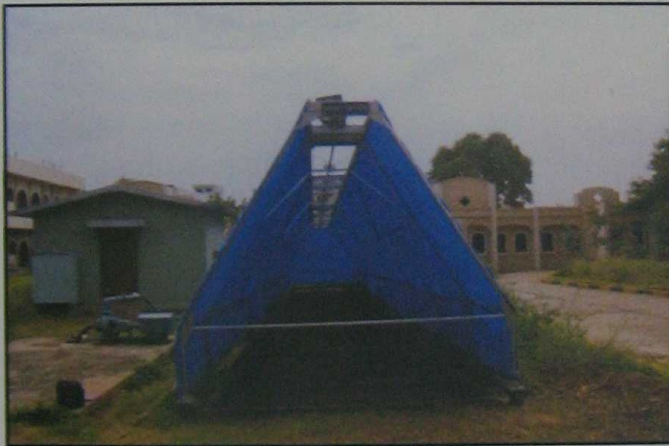
Fig. 6.1 Programmable rainfall simulator

A programmable rainfall simulator of 24 m x 3 m developed by CRIDA scientists (Figs. 6.1 & 6.2) was used to study the effectiveness of different conservation practices in controlled environment (Mishra, *et al.* 2003). Tipping bucket type runoff gauge was used to measure runoff rate and volume. Useful hydrological information like runoff, infiltration, sediment yield etc were generated from runoff plots under different land management practices (Table 6.1).

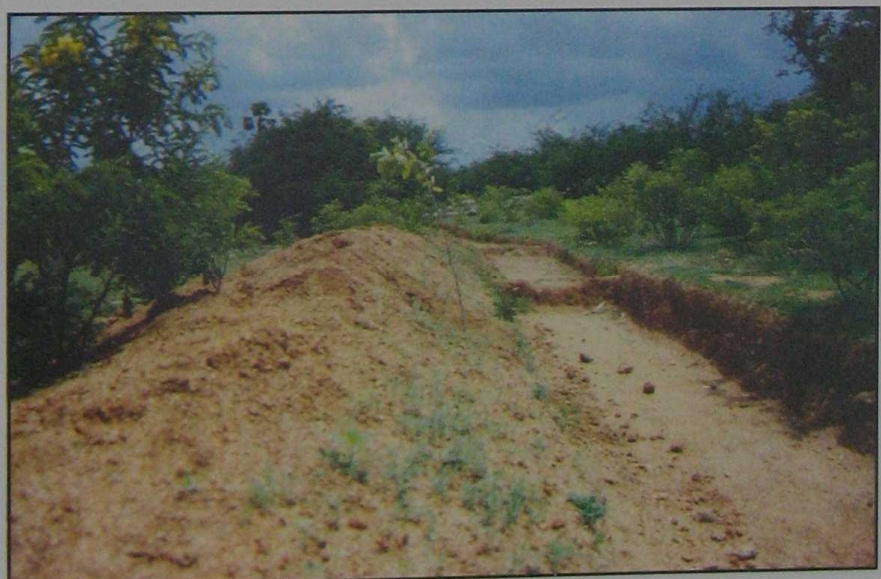
Fig. 7.1 Diversion channel in watershed area

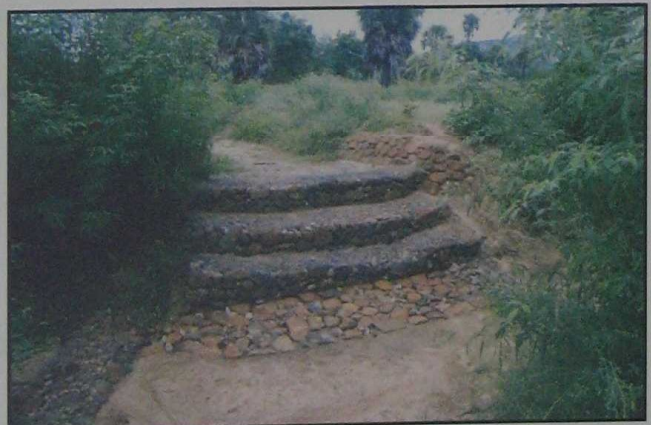
Fig. 7.4 Gabion drop structure

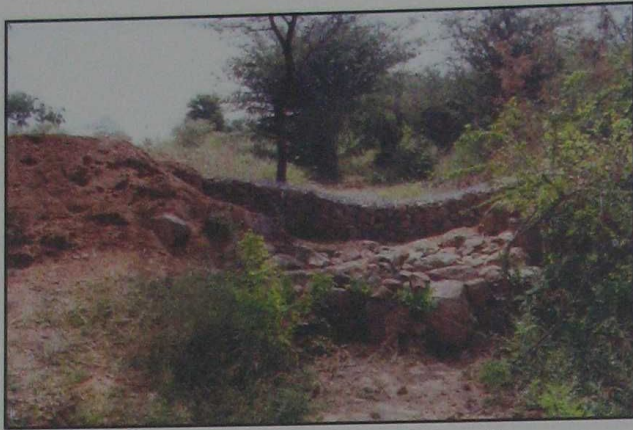
Fig. 7.5 Gabion structure in a gully

Concrete, masonry and brickwork have good resistance to compression but fail easily under tensile loads resulting from settlement. A small settlement of the structure can introduce stresses, which the structure is ill equipped to withstand. Gabion is a wire mesh basket filled with stones. The wire mesh holds the stones together and keeps them in place when the structure is subject to pressure. A gabion is a rigid, bulky mass, not easily shifted by water, and yet a row of linked gabions is fairly rigid and responds well to the terrain. The inherent flexibility of the gabions, the ability to bend without breaking seems to be the primary reasons for their success. These structures are used as checks in the waterways and gullies. The other advantages are:

- i) These structures are flexible to soil movement
- ii) They are permeable to water but retain soil
- iii) The materials are reusable, if structure fails
- iv) They are suitable when firm foundation is not available
- v) Height of the structure can be raised as and when required
- vi) Variable size stones can be used for construction

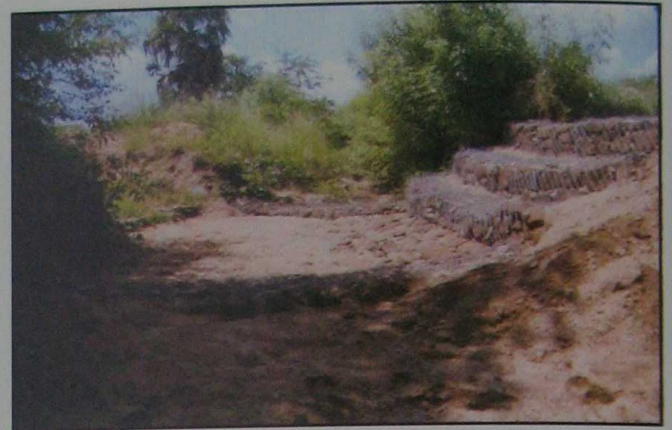
Fig. 7.6 Cascading gabion structure

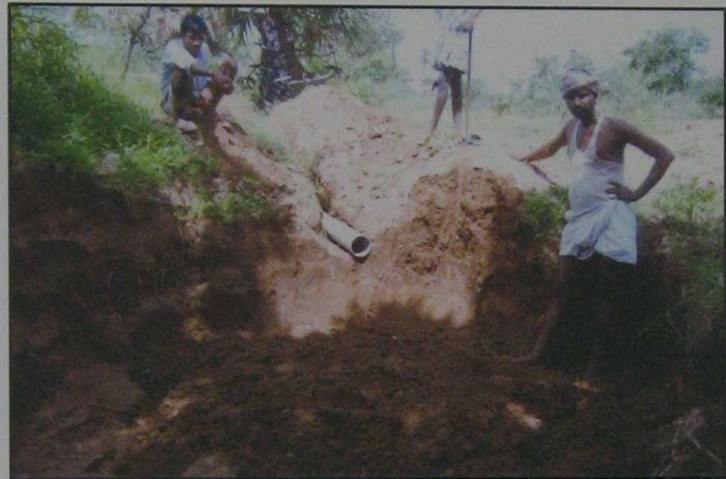
Fig. 7.7 Recharging pit

The purpose of the recharging pit constructed in the watershed is to collect and divert runoff water to the defunct well for recharging ground water. The runoff water from the hillock was diverted to the defunct open well (10 m deep) as shown in fig.7.7 through a PVC pipe, of 0.1m diameter. Loose boulders were put in the pit to filter the water before entering the well.

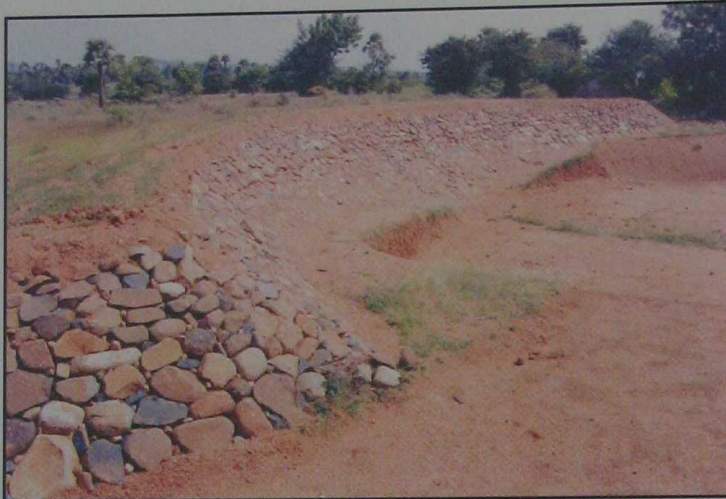
Fig. 7.8 Percolation pond in watershed area

The percolation pond is constructed considering the average runoff potential of the catchment area (3.04 ha). In the last 3 years the structure did not overflow. Hence, about 100 cum/ha of catchment can be taken for the design of percolation pond. Stone pitching was made for stabilizing the bund. The earthen bunds formed at the periphery of the percolation pond were covered with stylo and pongamia grasses.

Percolation ponds store runoff water for the purpose of recharging ground water. This is constructed across the waterway and is linked to the diversion drain to collect runoff for recharge of ground water and increase the water level in the nearby wells. The soil of the project site is highly permeable and is good to have such structures.

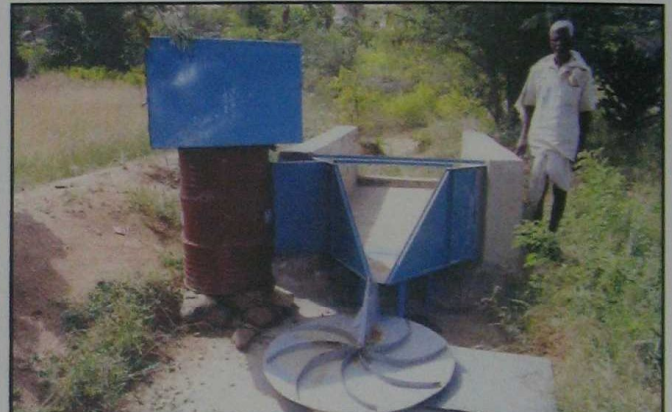
Fig.8.2 Stage level recorder installed in treated arable land

On an average the runoff producing rainfall is about 53% of total rainfall in untreated area and this got reduced to 21% with treatment of arable land. The expected maximum runoff was found to be 7% and the minimum being 0.5% from the treated area indicating the effectiveness of treatment. Also, the peak flow and soil loss are more in untreated lands.

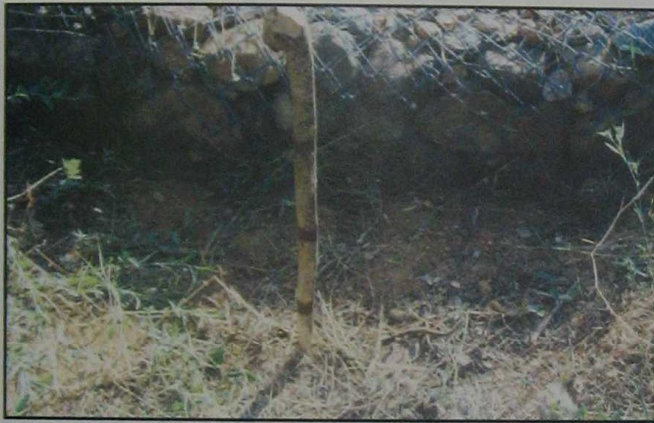
Fig.8.3 Graduated wooden peg at upstream side of gabion structure

The gabion and loose boulder structures were constructed in series for stabilizing the grade of channels, waterways and diversion drains. In due course it was observed that the displaced from catchment area are deposited upstream of these structures (Figs. 8.3 & 8.4). This process was measured by putting graduated wooden pegs on upstream side of structure and measuring the depth of deposited soil. It was also observed that the sand casting in the channels was reduced compared to earlier period indicating the reduction of soil erosion. It was found that four tons of soil has been conserved by gabion checks and check dams.

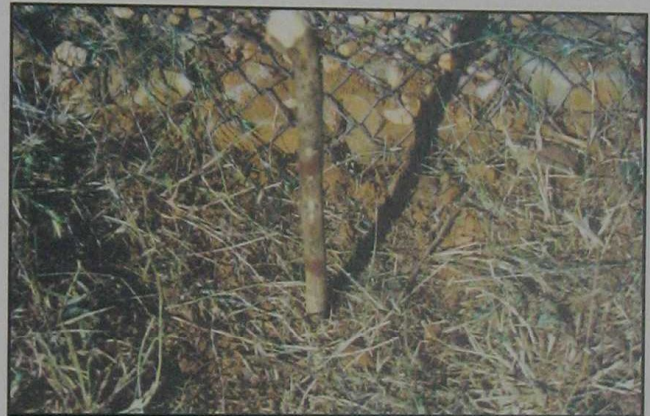
Fig.8.4 Deposited soil measure using graduated wooden peg

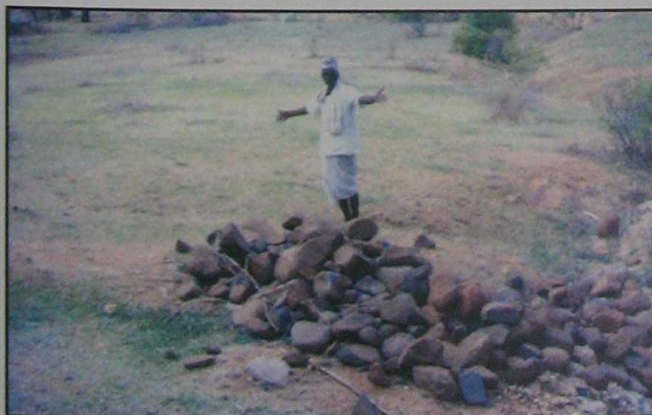
Fig.8.5 Farmer showing land affected by gully erosion

to divert the runoff. It has been observed that an area of 15 ha has been saved from rill and gully erosion after construction of waterway, diversion channel, etc. The area subjected to rill and gully erosion is now under cultivation. (Figs. 8.5, 8.6, 8.7 & 8.8).

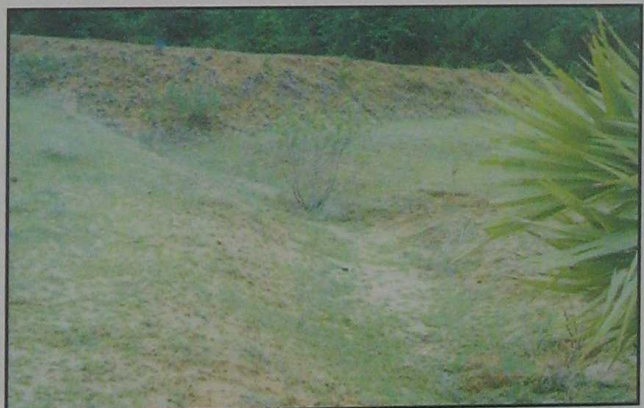
Fig.8.6 Reclamation of gully by constructing percolation pond in upstream of gully

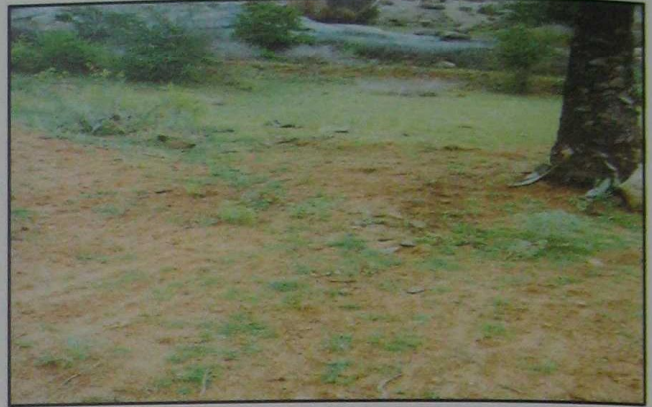
Fig.8.8 Control of gully by construction of diversion channel

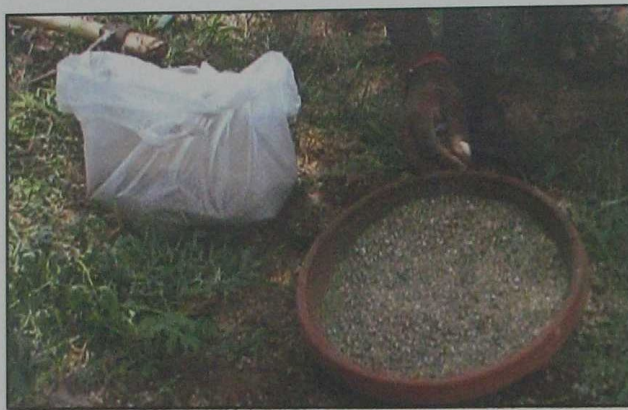
Fig.10.1 The grass seeds mixed with sand

All the bunds and waterways were green capped using Sabi grass (*Urochloa mosambicensis*), Guinea grass (*Panicum maximum*), Anjan (*Cenchrus ciliaris*) and Stylo (*Stylosanthes hamata*). The seeds were mixed with sand and sown in furrows opened by using tooth harrow and later covered by running local thorny bush (Figs. 10.1, 10.2 & 10.3). Stylo legume performed better than other grasses (Fig. 10.4). This indicates stylo is more drought tolerant and hardy than grass, which might be due to its deep root system. Grasses with shallow root system didn't perform well in shallow alfisols because of poor rainfall in the past three years. On either side of the bunds gliricidia, pongamia and cassia were planted. The farmers preferred gliricidia compared to pongamia and cassia.

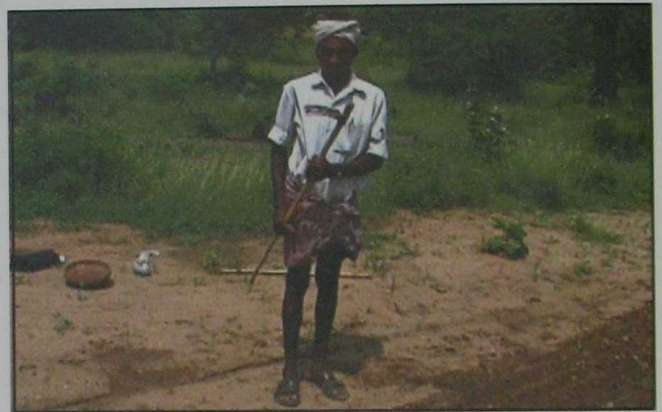
Fig.10.2 Furrows opened using tooth harrow for placing grass seeds

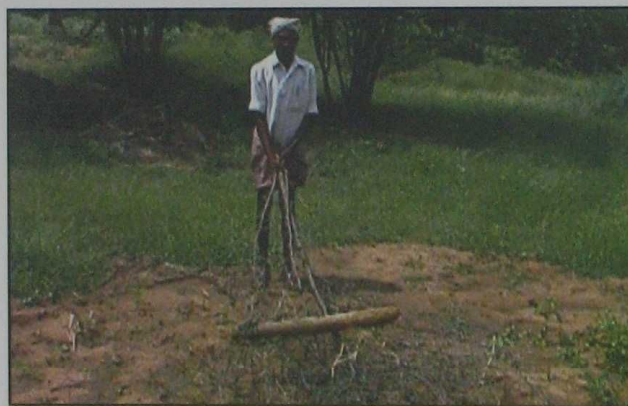
Fig.10.3 Covering of seed by running thorny bush

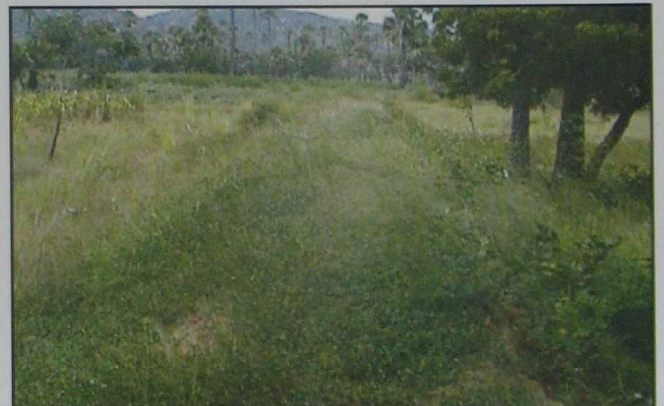
Fig.10.4 Green capping of bunds with stylo

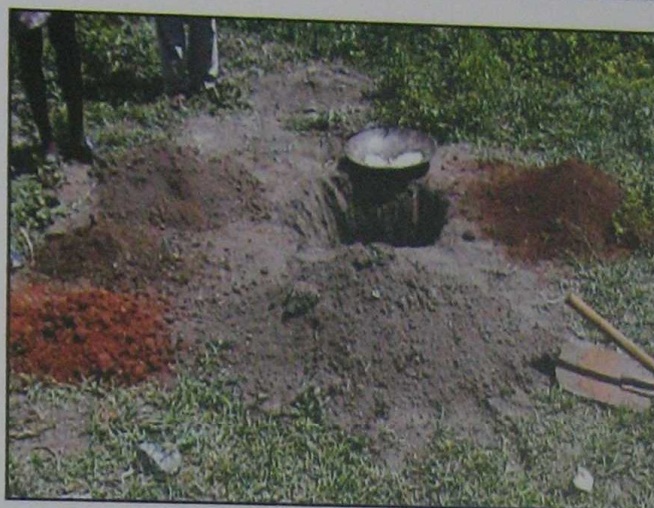
Fig.10.6 Removal of soil layer from pit

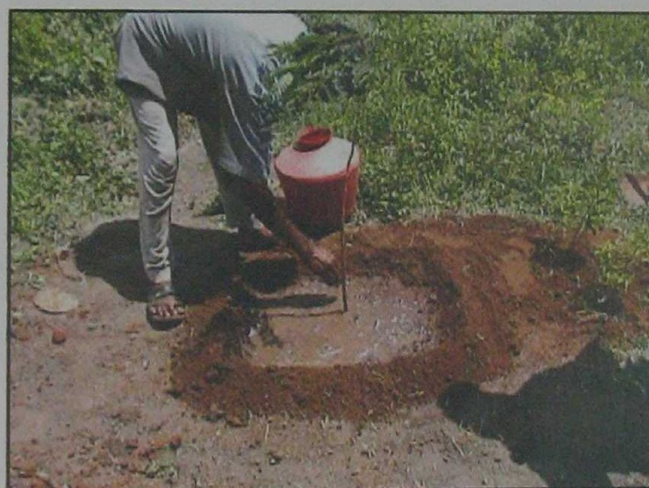
Fig.10.7 Saucer - a micro catchment for the plant

lack of groundwater because of drought for the past three years. Farmers were apprehensive about the survival of plants as there is acute shortage of even drinking water. To keep the interest alive and to support all the families in the village, planting of one tree of their choice near their residence was promoted. As an incentive, one bamboo tree guard was provided because the open space near their residence is prone to grazing / browsing by livestock. All the families of the S.S. Pally village were very happy to receive a fruit plant of their choice. Before taking-up plantation, a small training programme was organised to create awareness about site selection, digging, filling, planting and plant care. Men and women were trained about the making of pit (0.45 m x 0.45 m x 0.45 m) and micro-site improvement. Before digging, area of the pit was marked on the ground (Fig. 10.5). The pits were dug to a depth 0.45 m (Fig. 10.6) and care was taken to separate the soil layer wise (0-15 cm, 15-30 cm & 30-45 cm) and was kept separately (Fig. 10.6). Later, the topsoil (0-15 cm) was put at the bottom of the pit after removing stones, if any. The second layer (15-30cm) was mixed with two basket of FYM and one basket of tank silt, 100 gm of DAP and 5 gm of Thimmet granules. The mixture was filled to a height of 10 cm above the ground. After planting, the bottom soil was used for making saucer round the plant (Fig. 10.7) by leaving an opening for catching runoff.

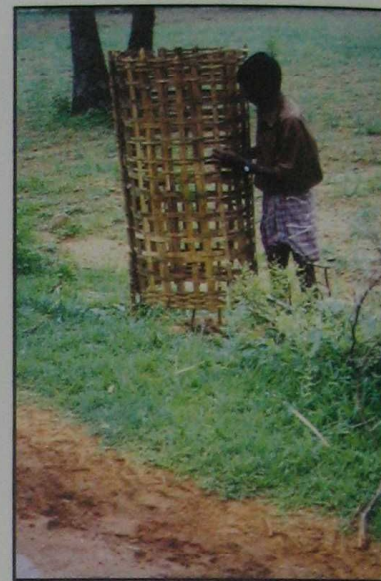
Fig.10.9 Bamboo tree guard

wage of Rs. 50/- per day per person (Fig. 10.8). This helped in improving the skill of the artisan as well as generated employment in the rural area. Bamboo tree guard (Fig. 10.9) was preferred over iron as it is not only costly but also prone to theft. Bitumen was applied at the bottom to improve the life of bamboo and to protect from termite. All the households received one plant each of their choice; most families preferred acid lime and their survival is 100 percent (Figs. 10.10 & 10.11). The following table gives the distribution of plants.

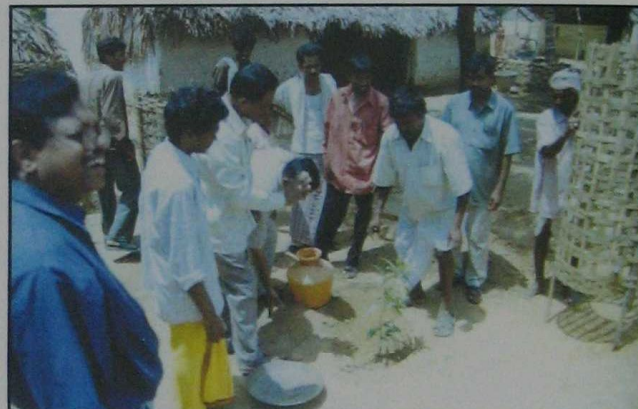
Fig.10.11 Tree planting and bamboo tree guard

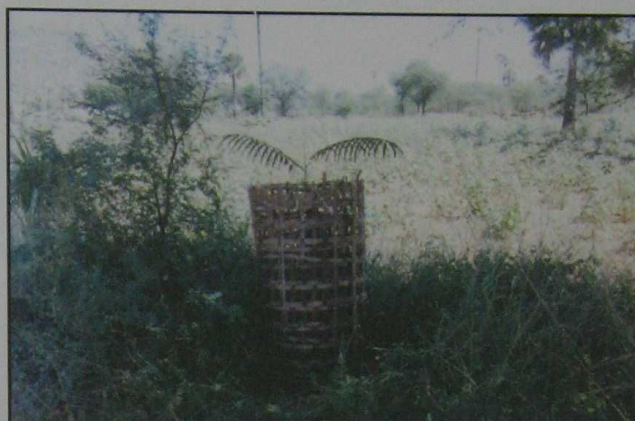
Fig.10.13 Gulmohar exceeded the height of tree guard within six months

To improve the aesthetic value, avenue plantation was carried out. The following plants were planted on either side of the road during July, 2004 (Table 10.2). The plants were protected by providing fence of local material and also bamboo tree guards. Two times supplemental watering was done during prolonged dry spells (Fig. 10.12). Gulmohar was found to be fast growing followed by copper pod tree and exceeded the height

of tree guards (Fig. 10.13). All the plants recorded more than 95% survival. Mulching was promoted for all the avenue and fruit plants using paddy husk (5 cm thickness) in the basin.
